WOOD DESTROYING PESTS AND ORGANISMS INSPECTION REPORT

BUILDING NO. 1111	STREET, CITY, STATE, ZIP Alma Street, Palo Alto CA 94301	Date of Inspection 3/30/2022	No. of Pages 10
  <div style="display: inline-block; vertical-align: middle;"> <p>We Make Homes Healthy™</p> <p>17427 Farley Road West Phone: 408-354-9944 Los Gatos CA 95030 Fax: 408-395-7934</p> <p>www.ThrasherTermite.com info@ThrasherTermite.com</p> </div>			
Firm Registration No. PR 5009	Report No. 27283	Escrow No.	
Ordered By: Sereno Group - Kevin Lu 350 Cambridge Avenue Suite 100 Palo Alto, CA 94306	Property Owner/Party of Interest Mariana Lin 1111 Alma Street Palo Alto, CA 94301	Report Sent To:	
COMPLETE REPORT <input checked="" type="checkbox"/> LIMITED REPORT <input type="checkbox"/> SUPPLEMENTAL REPORT <input type="checkbox"/> REINSPECTION REPORT <input type="checkbox"/>			
General Description: One story, wood framed, single family residence with wood exterior.		Inspection Tag Posted: Attic

27283

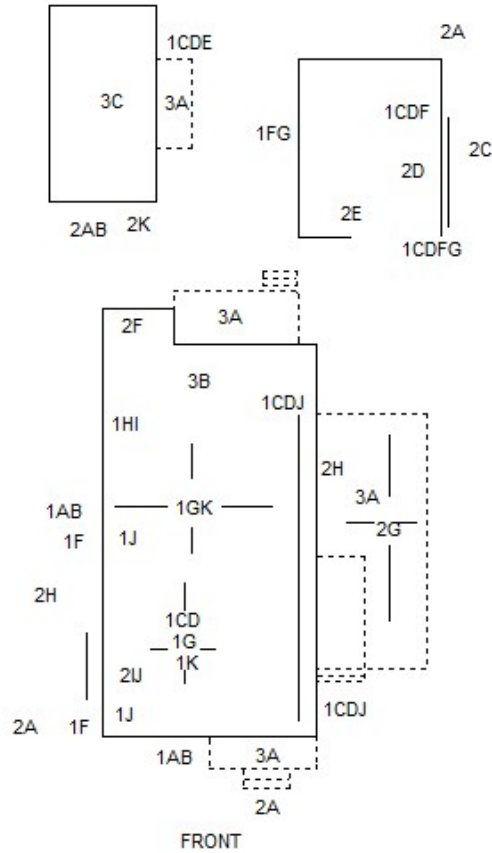
DIAGRAM NOT TO SCALE

ITEM 2C FINDING: Earth to wood contact conditions were noted at the right side ADU. The soil is touching the siding at the areas indicated on our diagram.

RECOMMENDATION: Regrade and/or lower the soil to correct this condition.
