Home Inspection Report

1111 Alma St, Palo Alto, CA 94301

LIN033122PF

Thursday, March 31st 2022

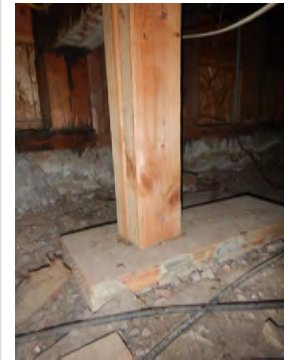
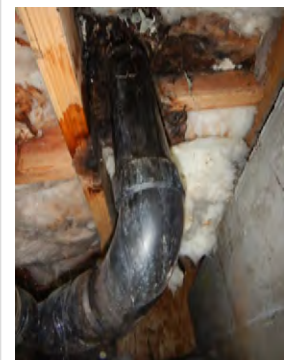
- 9

**UPGRADE** Cripple wall perimeter framing is in use under one or more sides of this home as viewed from the crawlspace. Basically, a cripple wall is a separate framed wall connecting the foundation with the wall and floor structure of the home. The base of the cripple wall is normally bolted to the foundation and the top portion is nailed to the floor / wall framing. During periods of seismic movement an unsupported cripple wall allows the home to sway. Some homes utilizing unsheathed cripple wall framing have swayed off of their foundation. We would suggest further inspection by a licensed framing contractor qualified to perform structural retrofitting / upgrading, including shear wall installation. This retro fitting would greatly increase the homes structural integrity in the event of an earthquake.

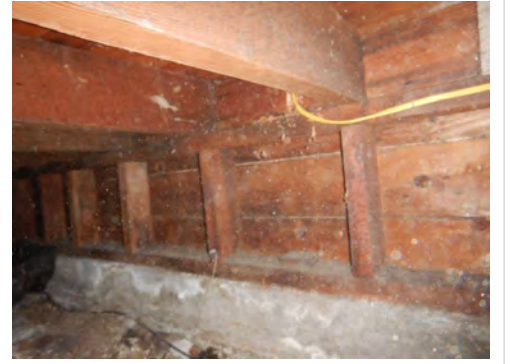
- 10

**REPAIR** Staining with moisture damage to the base of the exterior cripple wall wood framing was noted in the crawlspace at several locations. The level of damage indicates ongoing moisture intrusion at this location and the need for repair. Further evaluation of this condition is recommended. Repair to replace the affected material is needed. Review of a current pest control report is suggested and may provide additional information on this condition.

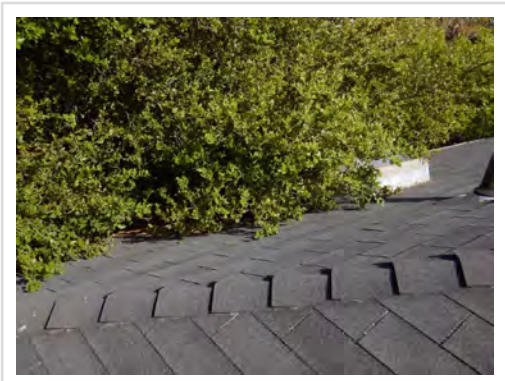
**MAINTENANCE** Overgrown vegetation or tree branches were contacting the roof at several locations along the north side of the home. Tree contact with the roof can cause damage to the roofing material from abrasion over time and can be an access point for pests and rodents. We suggest trimming the tree/s as needed to provide adequate clearance.

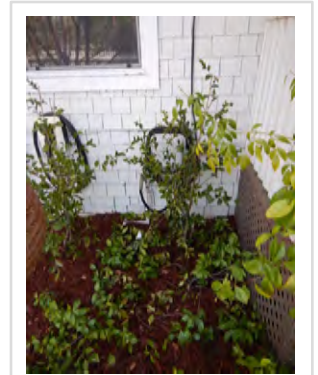
**FURTHER EVALUATION** The vegetation against the exterior wall at the front porch prevents a complete inspection of the exterior cladding. This is a limited area of inspection. No conclusions are made or offered in inaccessible areas. Maintaining a clearance to the exterior cladding in this area is recommended to provide adequate air circulation. High moisture levels and abrasion can lead to damage of the exterior wall surfaces. Review of this area when trimmed to assure a well-sealed surface is provided is suggested.

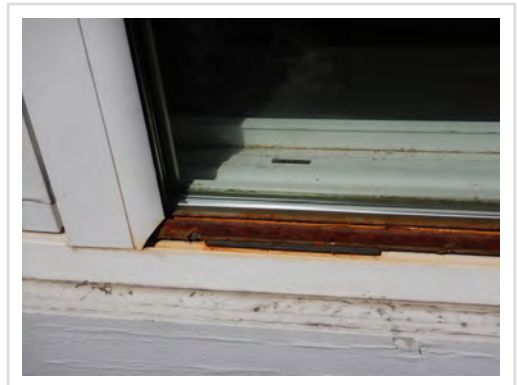
**REPAIR** Corrosion damage and/or detachment of the window glass seal strip/s with voids was noted at the kitchen. In some cases, damaged or missing window glass seal strips can be a source of leakage and resulting moisture damage. Repair or replacement of the window is needed to correct this condition. Consulting with a qualified glazer (window specialist) for further evaluation and repair as needed is suggested.

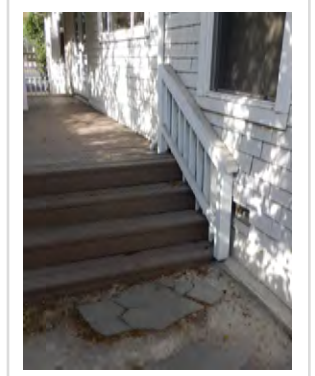
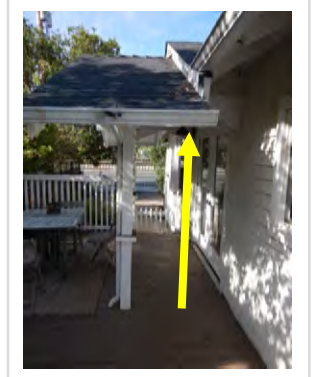
**SAFETY ISSUE** A low headroom clearance is provided at the rafter tails and/or wood framing above the walking surface. A low clearance (less than 6' 8") can allow personal injury by accidental head contact to occur. **This condition presents a safety hazard and requires corrective action to reduce the potential for injury.** While improvement to provide adequate clearance to pass below this point is strongly recommended changes may not be practical. Caution in this area is advisable.

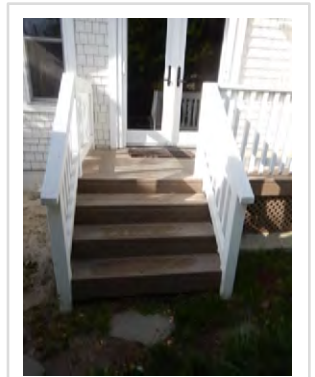
**SAFETY ISSUE** The door landing step down to grade varies in height and exceeds the maximum 8" rise as is required by commonly accepted by current construction standards and can be a trip and fall hazard. **This condition presents a safety hazard and requires corrective action to reduce the potential for injury.** Repairs to correct this condition are strongly recommended.

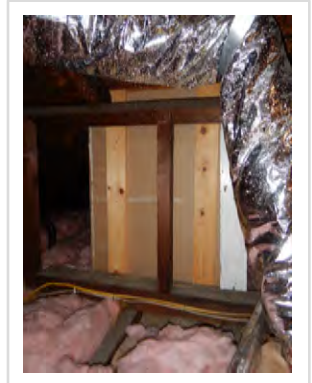
The floor cavity visible in the crawlspace has been insulated with rolled fiberglass insulation measuring approx. 6" in thickness. This level of insulation has an R-19 rating.

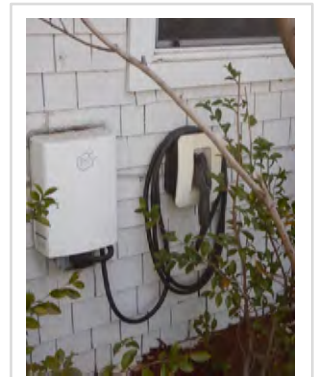
Electric car charger equipment has been installed at the west exterior wall. Systems of this type provide rapid charging of electric cars. This system is beyond the scope of the inspection. Consulting with the seller or current occupant for additional information on the history and performance of this system is suggested. Consulting with a qualified specialist in the appropriate trade for inspection and testing to verify the current condition of this system is suggested.

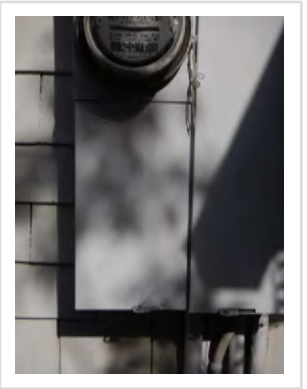
**SAFETY ISSUE** The utility company seal tag on the meter ring on main panel box was damaged or missing. A secured meter cover is required to prevent access to live electrical conductors behind the meter. The accessible electrical connections can be a risk of electrical shock. **This condition presents a safety concern and requires corrective action.** Securing the meter ring as needed is strongly recommended. Contacting the local utility for review and repair of this condition is strongly recommended.

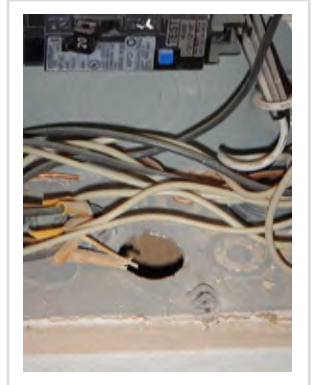
**REPAIR** One or more of the neutral conductors within this electrical panel have doubled up on the neutral bus bar. This is referred to as "double taps" and requires repair. Each lug should be filled with a single conductor. Consulting with a qualified electrical contractor for repair is recommended.

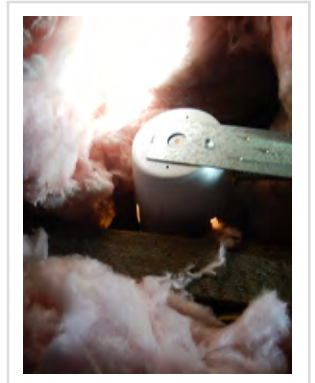
**SAFETY ISSUE** The ceiling recessed light fixtures visible in the attic are not rated for installation with insulation contact. Insulation when placed in contact with one or more of the recessed light fixture/s can overheat the fixture and be a fire hazard. **This condition presents a safety concern and requires corrective action.** Light fixtures of this type require a 3" clearance to insulation. Review of the manufacturer's installation guidelines for further information on this matter is suggested. An isolation cover can be installed to separate the space between the light fixture and the insulation. Improvements or replacement of the non-I/C recessed light fixtures with 'insulation contact' I/c rated fixtures units is indicated. Corrective action in this area is strongly recommended.

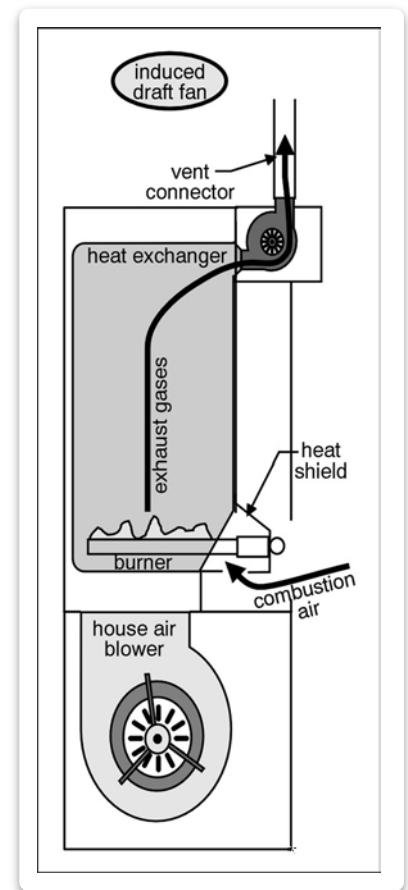
**REPAIR** A utility outlet receptacle has not been provided at the furnace in the attic. A power source is required for service of this appliance and should be installed in close proximity to the furnace. Repairs to correct this condition are recommended.

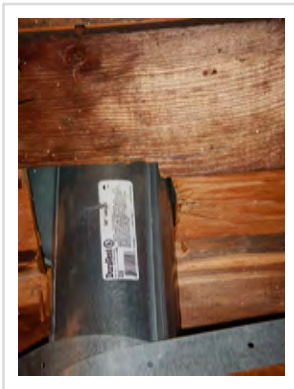
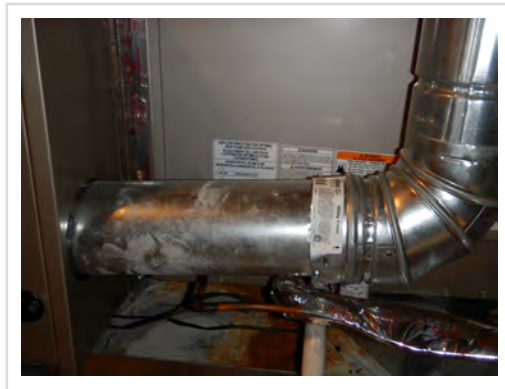
**SAFETY ISSUE** The single wall metal exhaust vent pipe material in the attic is not approved for this application. The exhaust vent in the attic requires double wall (Type 'B' pipe) system. Single wall vent pipe can be a risk of fire. ***This condition presents a safety hazard and requires corrective action to reduce the potential for injury.*** Further evaluation and repair by a qualified heating and cooling specialist is strongly recommended.

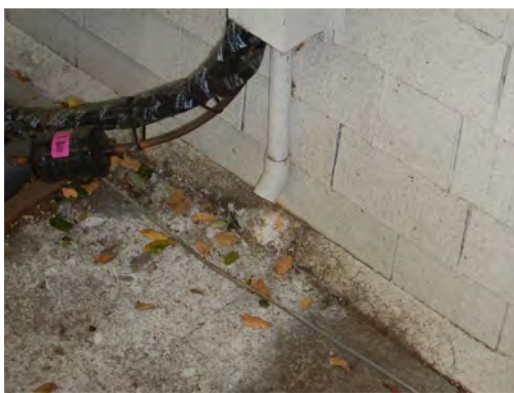
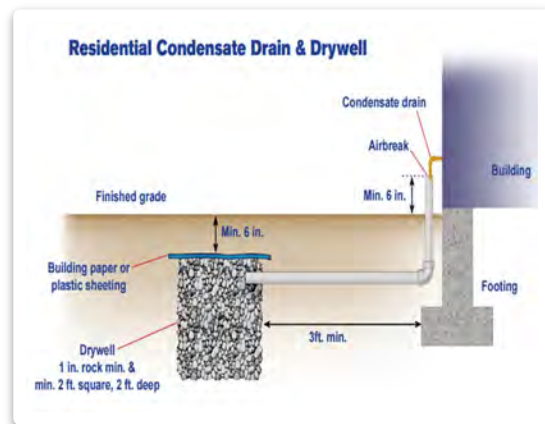
**UPGRADE** The condensate drain terminates on grade near the foundation at the exterior wall. Local construction standards commonly require the drain to discharge into a 'dry-well' system away from the foundation. Basically, this dry well contains drain rock in a protected below grade area. Consulting with the local building department for additional information on requirements for this system is suggested. Improvements as needed are recommended.

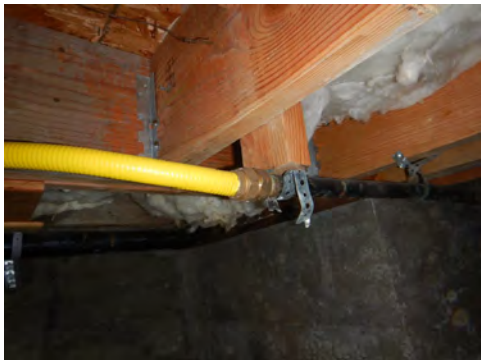
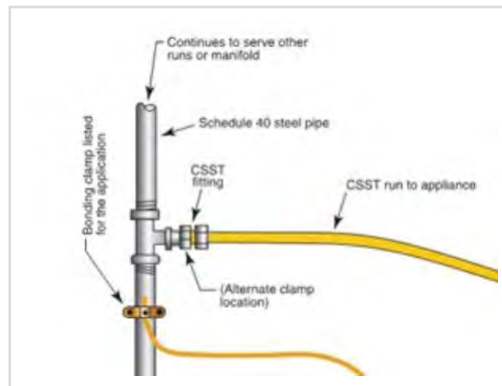
**FURTHER EVALUATION** The gas distribution piping system in the crawlspace has been modified with the addition of CSST (Corrugated Stainless-Steel Tubing). Recent changes to requirements for installation of this system require a bonding conductor connection near the transition to the CSST piping to assure a proper ground. The inspector did not locate or verify the bonding conductor connection. California Senate Bill 988 and California Business and Professions Code 7196.2 required comment related to the presence of corrugated stainless-steel tubing (CSST) electrical bonding: "Manufacturers of yellow corrugated stainless-steel tubing believe that yellow corrugated stainless-steel tubing is safer if properly bonded and grounded as required by the manufacturer's installation instructions. Proper bonding and grounding of this product can only be determined by a licensed electrical contractor." Improperly bonded gas piping poses a potential safety concern. Further evaluation and repair as needed by a qualified electrical contractor is recommended.

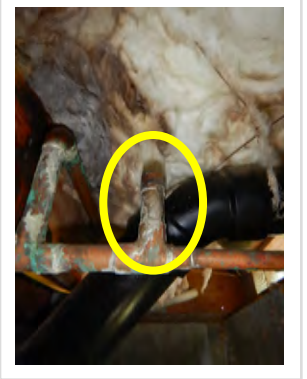
**REPAIR** Plastic pipe has been added to the domestic supply piping in the crawlspace at the rear corner. Plastic pipe of this type (Schedule #40) is not listed as an approved piping material for residential housing. Repair to replace the plastic piping with a properly rated material is suggested. Consulting with a qualified plumbing contractor for additional information on this condition is recommended.

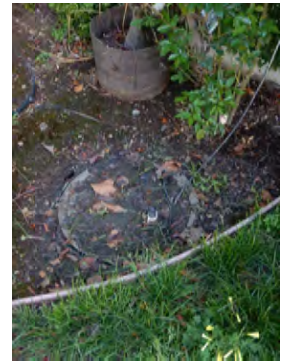
**SAFETY ISSUE** The cover plate was wet with ongoing leakage of waste water / sewage. An open waste system leaking sewage is a health hazard, risk of illness and injury. **This condition presents a safety hazard and requires corrective action to reduce the potential for injury.** Immediate repair to seal the cover is needed to correct this condition. We suggest consulting with a qualified plumbing contractor for further evaluation and repair as needed. Repairs to correct this condition are strongly recommended.

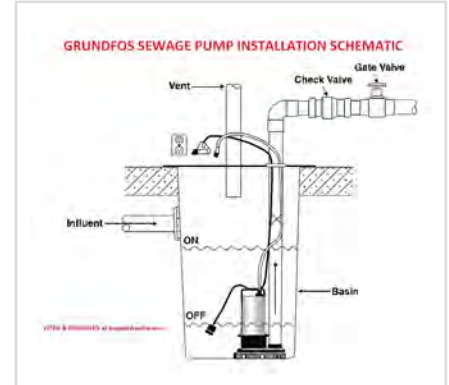
**REPAIR** A visible connection to a vent pipe for the ejector vessel was not found. A vent through the roof is required at system for sufficient venting for the vessel to maintain neutral pressure. The lack of proper venting can affect drainage. Review of the manufacturer's installation guidelines for further information on the maintenance requirements for this system is suggested. (See the image for additional detail) Consulting with a qualified plumbing contractor for further evaluation of this installation is recommended.

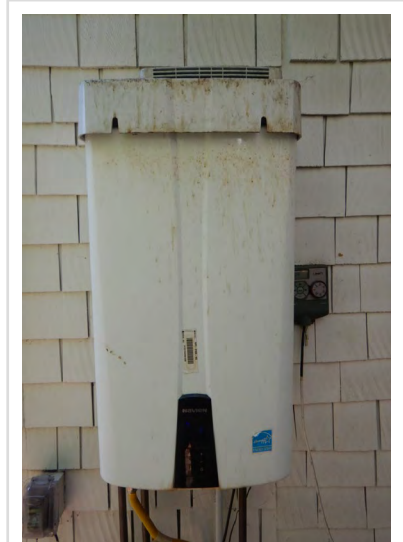
CLIENT ADVISORY Installation of a tankless water heater to replace the original model has been completed. The installation of a tankless water heater requires specific changes to the gas meter size, gas supply system, venting, etc. and commonly requires a building permit issued by the local jurisdiction have authority as well as onsite inspection/s to verify code compliance. We suggest review of the plans, permits and/or associated documentation related to this installation. Verification of the final inspection sign off is suggested. Consulting with the seller or current occupant for additional information on this matter is suggested.

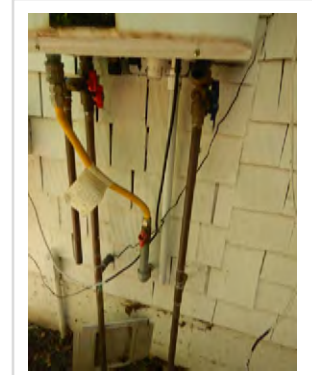
**REPAIR** Insulation has not been installed on the cold-water supply pipe and/or at the out-flow hot water pipe near the water heater. Heat loss at this location reduces the efficiency of the water heater and increases the cost of operation. Review of the manufacturer's installation guidelines and current energy standards for further information and requirements on this system is suggested. Generally, the first five (5) feet of pipe on both the cold and hot side are insulated for increased energy efficiency. Improvement to insulate the piping system at this location is suggested.

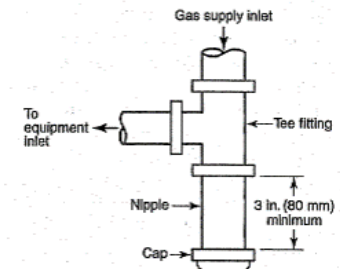
**REPAIR** A sediment trap at this gas appliance has not been provided. Traps are designed to catch debris that may travel in the gas supply pipe and is commonly required by the manufacture's installation sheet. Review of the manufactures installation specifications and requirements for information related to the installation of this system is suggested. Repairs to correct this condition as needed are recommended.

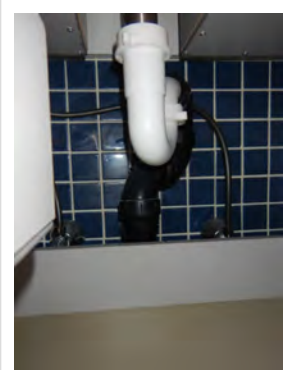
**SAFETY ISSUE** The sink drainpipe has been installed with an 'S' configured and without adequate venting. This drain configuration is improper and can allow the trap to siphon dry during use. Without water in the trap, sewer gases can enter the home. ***This condition presents a safety concern and requires corrective action.*** Further evaluation and repair as needed by a qualified plumbing contractor is recommended.

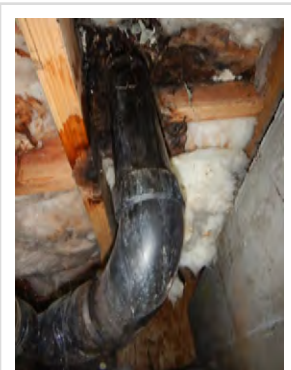
**REPAIR** The toilet was noted to be actively leaking below in the crawlspace. Ongoing leakage can lead to moisture damage of the surrounding area. We suggest reinstalling the toilet with a new wax ring to correct this condition. We suggest consulting with a qualified plumbing contractor for further evaluation and repair as needed.

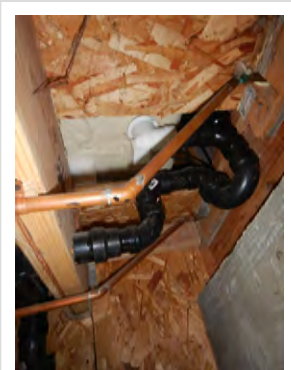
**SAFETY ISSUE** The drainpipe below the bathtub has been installed with a 'S' trap configuration and without adequate venting. This drain configuration is improper and can allow the trap to siphon dry during. Without water in the trap, toxic and explosive sewer gases can enter the home. ***This condition presents a safety hazard and requires corrective action to reduce the potential for injury.*** Further evaluation and repair as needed by a qualified plumbing contractor is recommended.

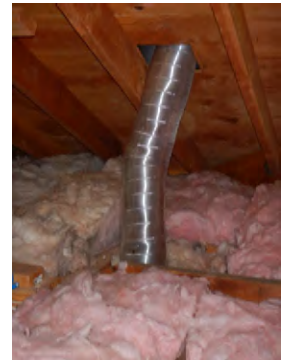
**UPGRADE** The flexible ribbed aluminum type of ducting used in the attic is not recommended by the manufacture and is prone to catching cooking grease over time. This non-rated ducting material has been used to vent the cooktop exhaust fan to the exterior. Replacing the existing ductwork with smooth wall sheet metal ducting is recommended.
