Saber Roofing, Inc.

Inspection Report

**1111 Alma Street
Palo Alto, CA 94301**

Inspected on Tue, Apr 5 2022 at 10:00 AM

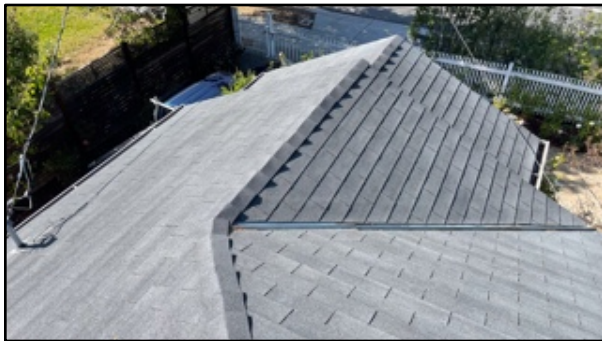
Figure 1-1

HOUSE: The above mentioned roof system is an asphalt shingle (1 layer) which has a rough life expectancy of 20-25 years with proper maintenance and care. This roof system appears to be approximately 15 years old. With the below mentioned deficiencies being rectified and proper maintenance and care, this roof should provide for a watertight condition for the next 5+ years. This is in no way a stated or implied warranty, but an opinion based on a visual inspection of the roof system.

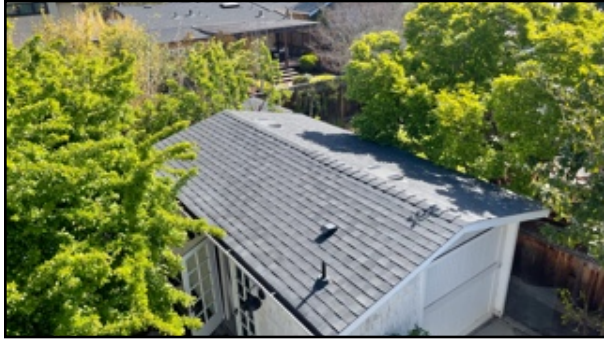
Figure 2-1

RIGHT SIDE ADU: The above mentioned roof system is an asphalt shingle (1 layer) which has a rough life expectancy of 25+ years with proper maintenance and care. This roof system appears to be approximately 2-6 years old. With the below mentioned deficiencies being rectified and proper maintenance, this roof system should provide for a watertight condition for the next 10+ years.

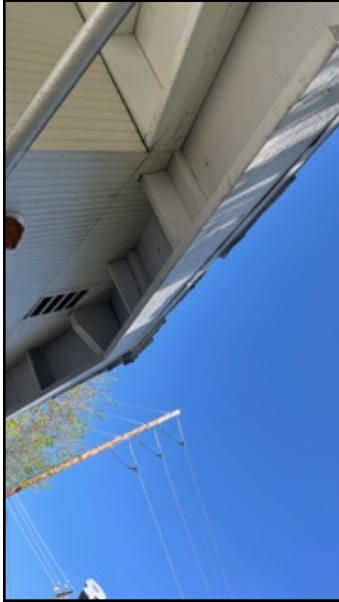
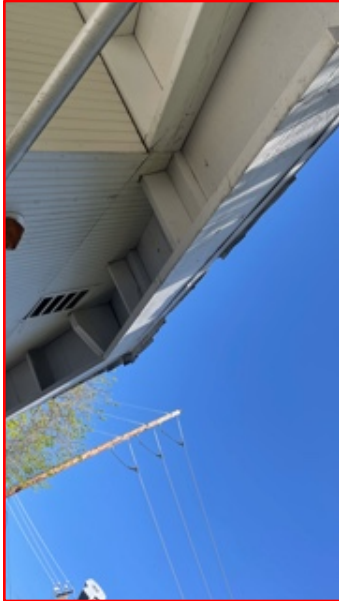
Figure 4-1

The shingles do not overhang the recommended 1/2-1" at miscellaneous locations of the rear left side ADU. Repairs recommended.

1) The shingles do not overhang the recommended 1/2-1" at miscellaneous locations of the rear left side ADU. Repairs recommended.

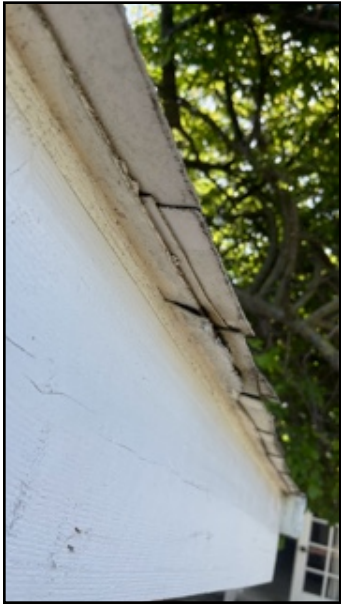
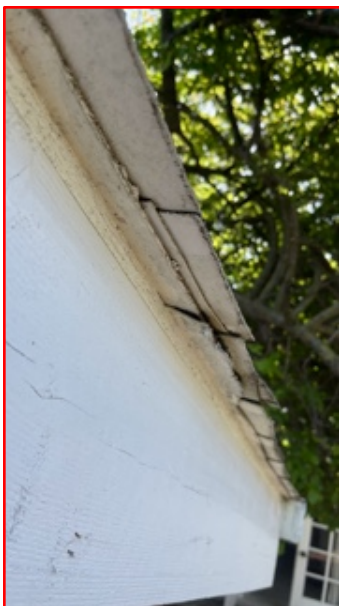
Figure 5-1

No starter strip/shingle was installed at the eaves nor appropriate edge metal/nosing to protect the edge of the plywood at the rear left side ADU. Repairs recommended.

2) No starter strip/shingle was installed at the eaves nor appropriate edge metal/nosing to protect the edge of the plywood at the rear left side ADU. Repairs recommended.

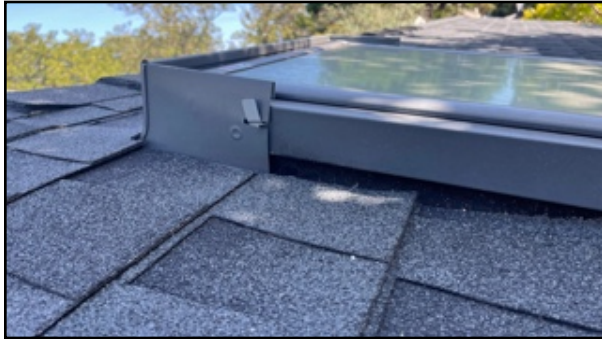
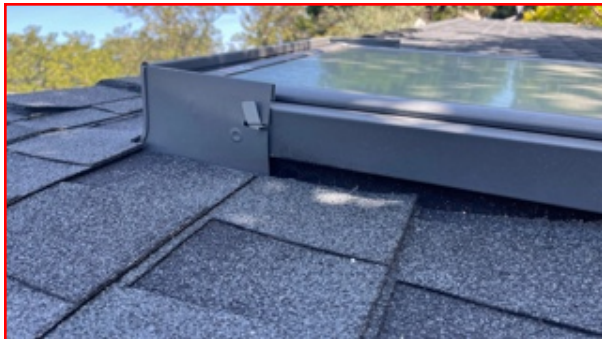
Figure 6-1

Missing and uplifted skylight flashings were noted at the bathroom skylight of the rear left side ADU. Repairs recommended.

3) Missing and uplifted skylight flashings were noted at the bathroom skylight of the rear left side ADU. Repairs recommended.

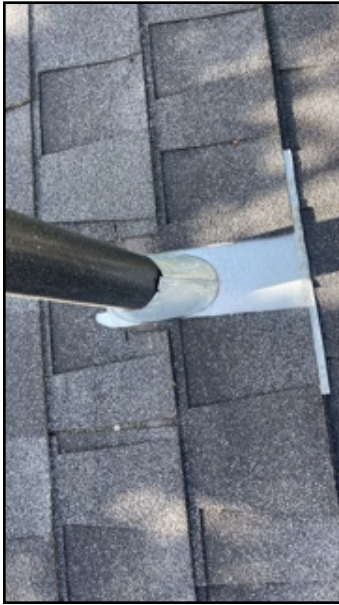
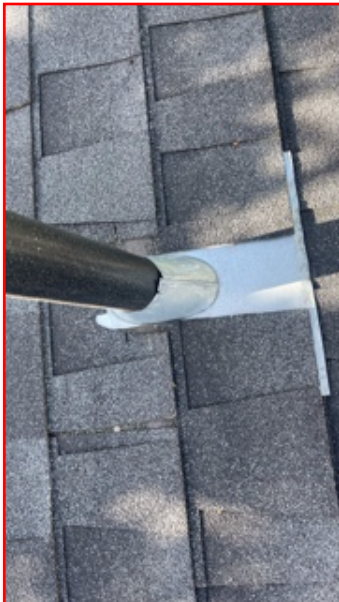
Figure 7-1

Inadequately sealed roof jacks were noted on the rear left side ADU, repairs recommended.

4) Inadequately sealed roof jacks were noted on the rear left side ADU, repairs recommended.

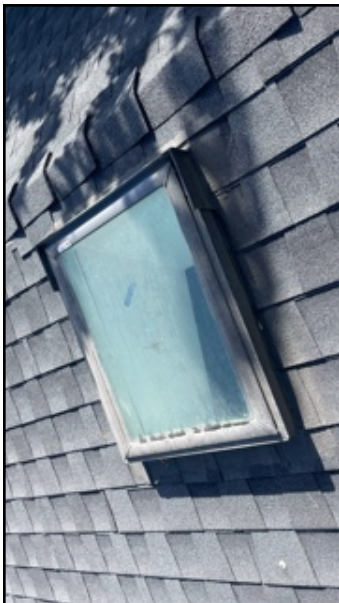
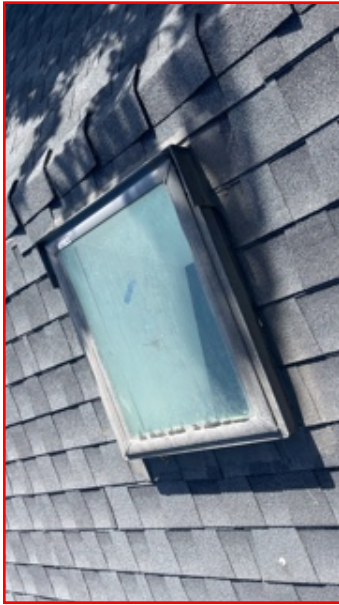
Figure 8-1

Sealant has been applied to the entire skylight and flashing kit at the living room skylight on the rear left ADU. Repairs recommended.

5) Sealant has been applied to the entire skylight and flashing kit at the living room skylight on the rear left ADU. Repairs recommended.

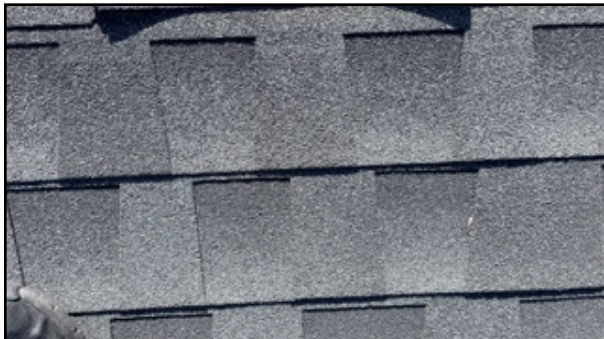
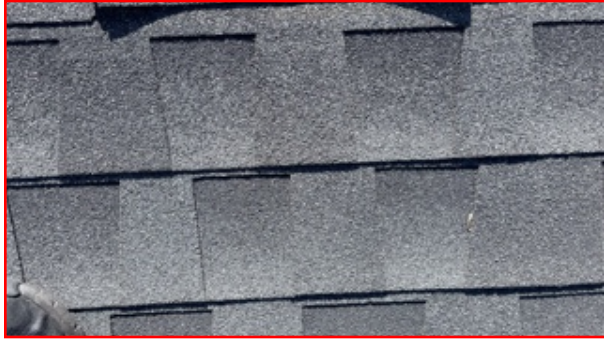
Figure 9-1

The existing shingles on the rear left side ADU are overexposed and not installed per manufacturer's recommendations. No repairs are possible to correct this deficiency.

6) The existing shingles on the rear left side ADU are overexposed and not installed per manufacturer's recommendations. No repairs are possible to correct this deficiency.

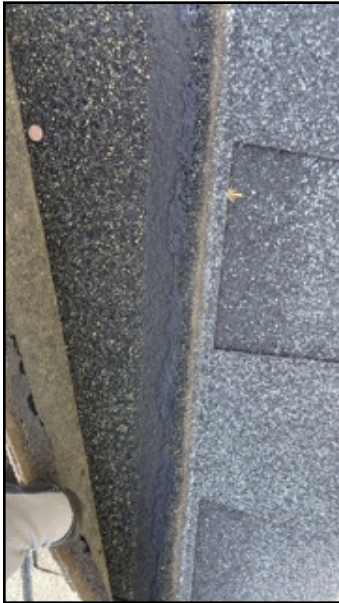
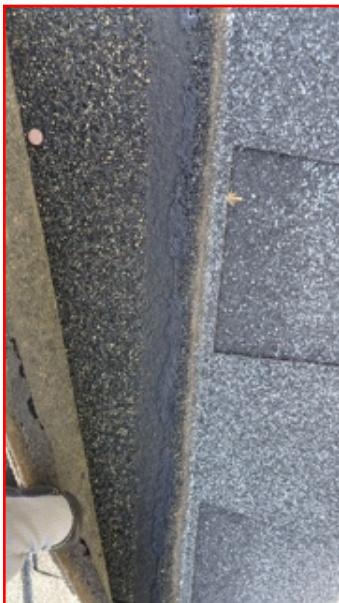
Figure 10-1

The existing shingles on the rear left side ADU were not nailed per manufacturers recommendations nor industry standards. No plausible repairs are possible for this deficiency.

7) The existing shingles on the rear left side ADU were not nailed per manufacturers recommendations nor industry standards. No plausible repairs are possible for this deficiency.

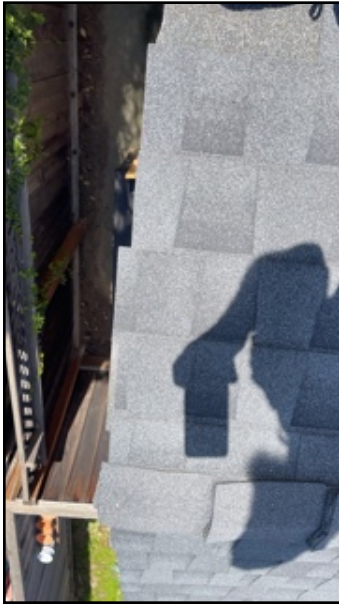
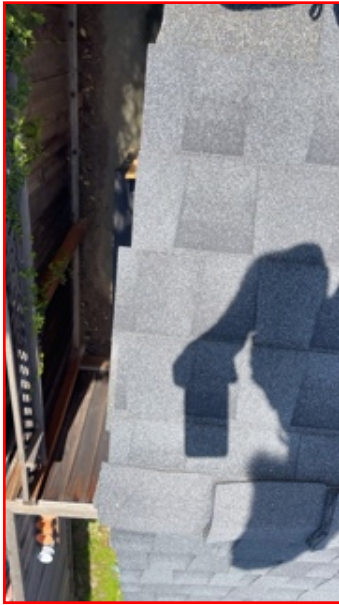
Figure 11-1

Missing shingles and improperly installed shingles were noted at the rear left side ADU. Repairs recommended.

8) Missing shingles and improperly installed shingles were noted at the rear left side ADU. Repairs recommended.

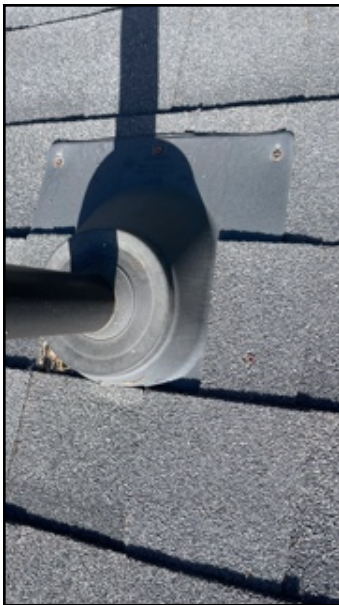
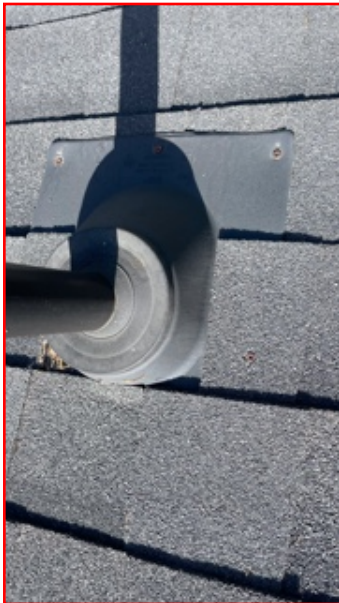
Figure 12-1

Exposed fasteners were noted at the right side ADU and main house. Repairs recommended.

9) Exposed fasteners were noted at the right side ADU and main house. Repairs recommended.

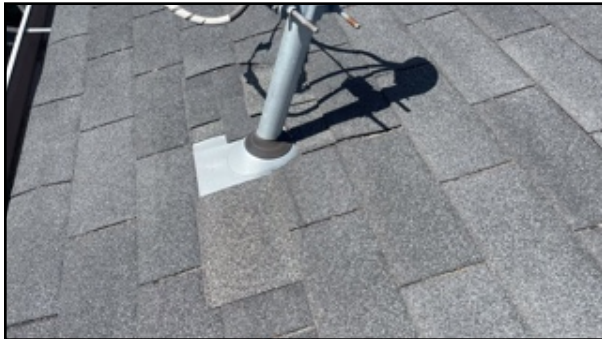
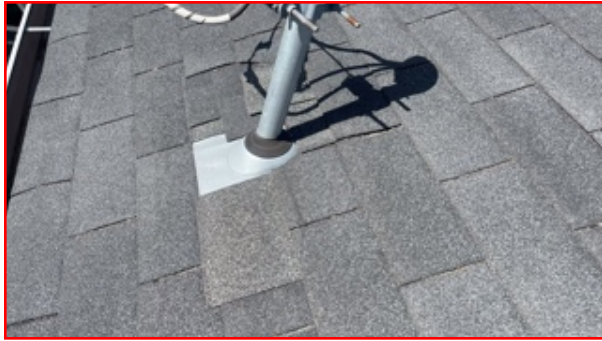
Figure 13-1

Previous repairs were noted to the elect riser riser and adjacent shingles. The quality of these repairs cannot be verified but is hereby noted.

10) Previous repairs were noted to the elect riser riser and adjacent shingles. The quality of these repairs cannot be verified but is hereby noted.

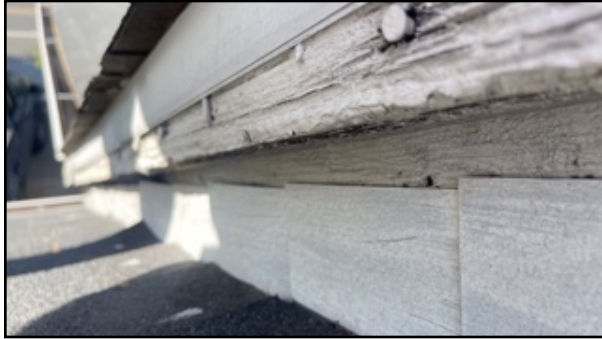
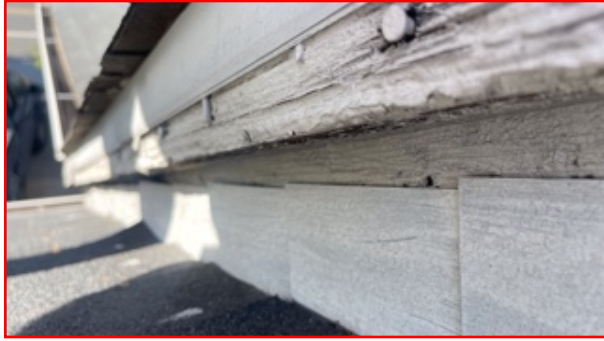
Figure 14-1

Inadequately sealant and/or improperly counter-flashed step shingles were noted at multiple roof to wall junctions. Repairs recommended to ensure proper waterproofing.

11) Inadequately sealant and/or improperly counter-flashed step shingles were noted at multiple roof to wall junctions. Repairs recommended to ensure proper waterproofing.

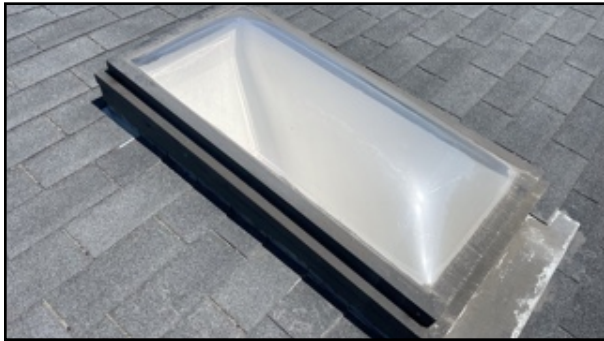
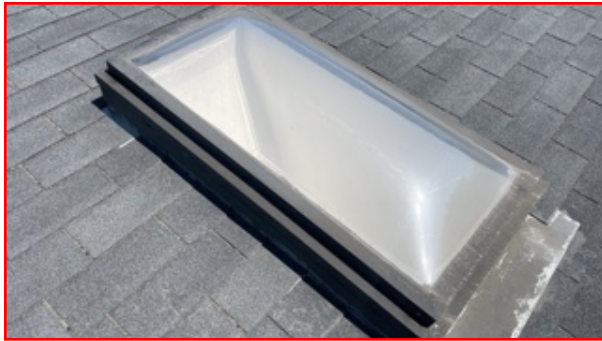
Figure 15-1

Minor crazing was noted to the main house acrylic skylight. No repairs are required at this time, but continue to monitor for water intrusion.

12) Minor crazing was noted to the main house acrylic skylight. No repairs are required at this time, but continue to monitor for water intrusion.

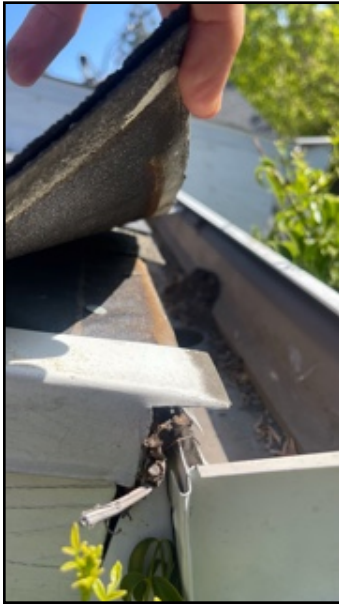
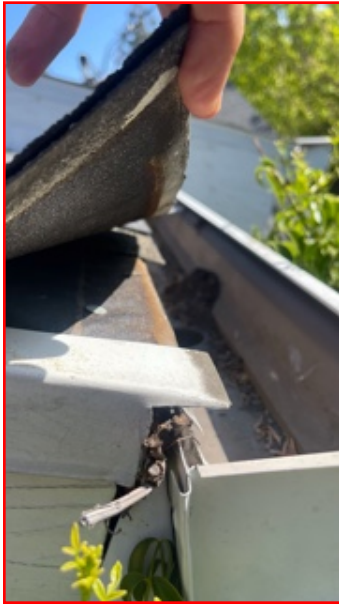
Figure 16-1

No starter shingles were used at the main house front eave(s). No plausible repairs are required at this time, but continued monitoring is recommended.

13) No starter shingles were used at the main house front eave(s). No plausible repairs are required at this time, but continued monitoring is recommended.

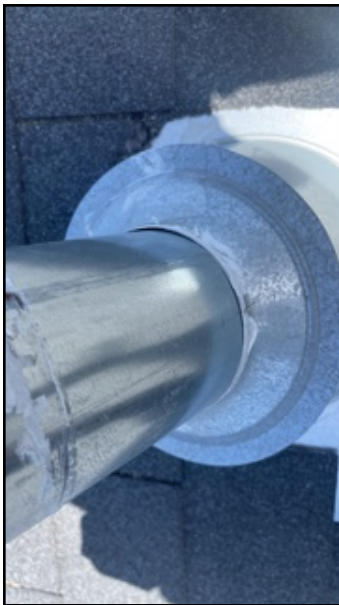
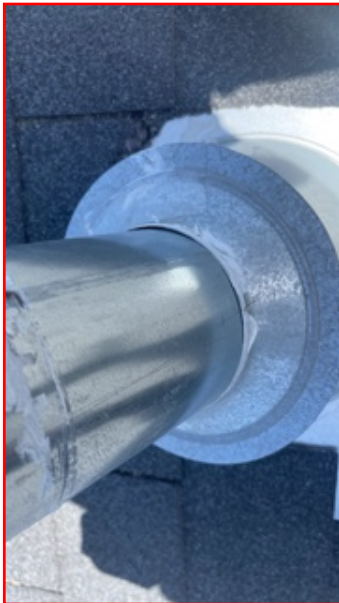
Figure 17-1

The existing storm collar on the furnace/water heater vent pipe is not adequately sealed to the base flashing. Repairs recommended.

14) The existing storm collar on the furnace/water heater vent pipe is not adequately sealed to the base flashing. Repairs recommended.

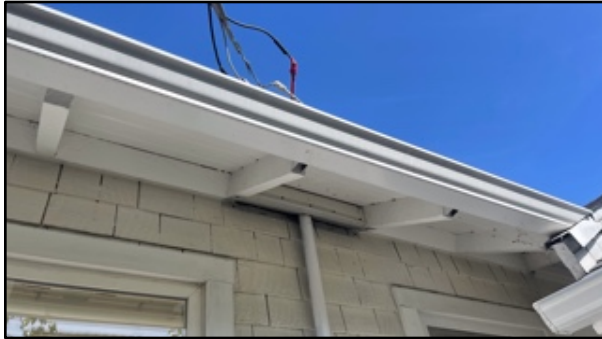
Figure 18-1

The existing gutters appear to be 5" aluminum ogee style with 2" round downspouts. In general the gutters were in serviceable condition unless otherwise noted.

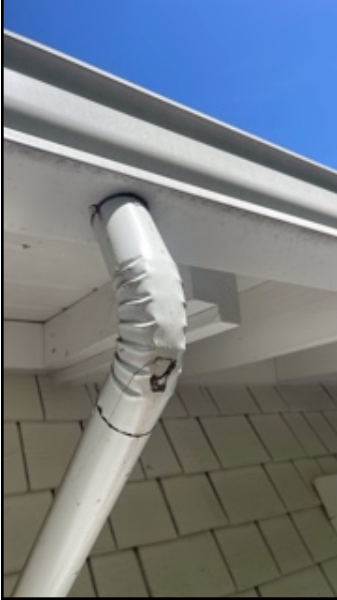
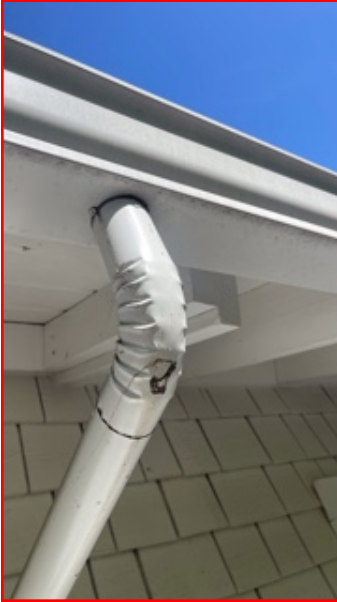
Figure 19-1

**Comment 19:**
Multiple stains/leaks were noted at the drop outlet/downspout connections.
Sealant repairs recommended.

15) Multiple stains/leaks were noted at the drop outlet/downspout connections. Sealant repairs recommended.

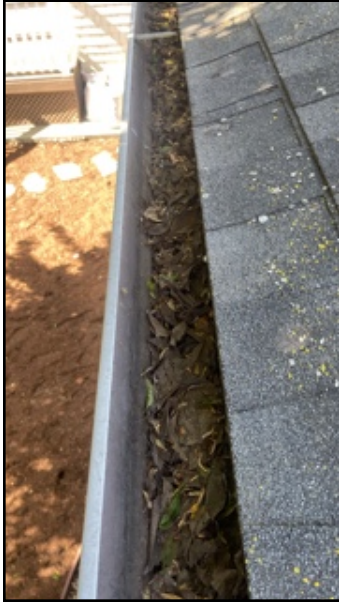
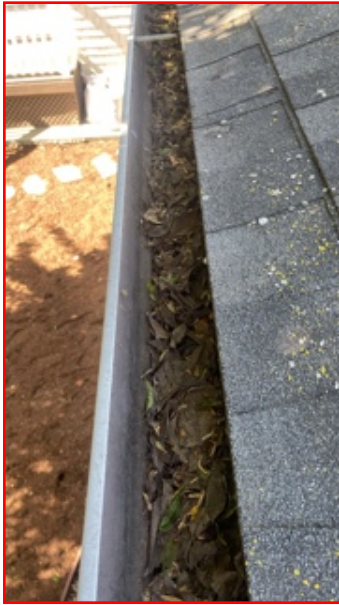
Figure 20-1

Considerable debris build up was noted inside the gutters. Regular maintenance recommended to ensure proper water drainage.

16) Considerable debris build up was noted inside the gutters. Regular maintenance recommended to ensure proper water drainage.

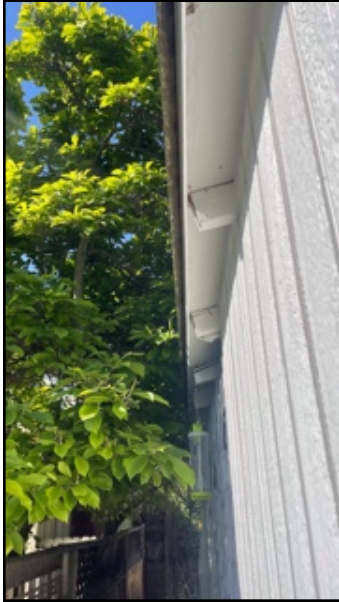
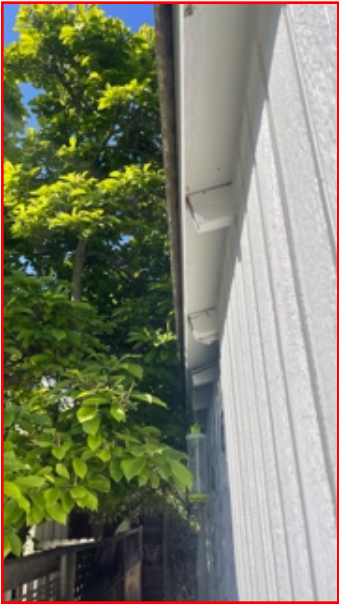
Figure 21-1

Portions of the ADU's do not have gutter systems installed. Recommend continued monitoring to see if gutter installation is required.

17) Portions of the ADU's do not have gutter systems installed. Recommend continued monitoring to see if gutter installation is required.
