FOUNDATION & DRAINAGE INSPECTION REPORT

1111 Alma Street, Palo Alto

Inspection Date: 4/4/2022

Address: 1111 Alma Street, Palo Alto

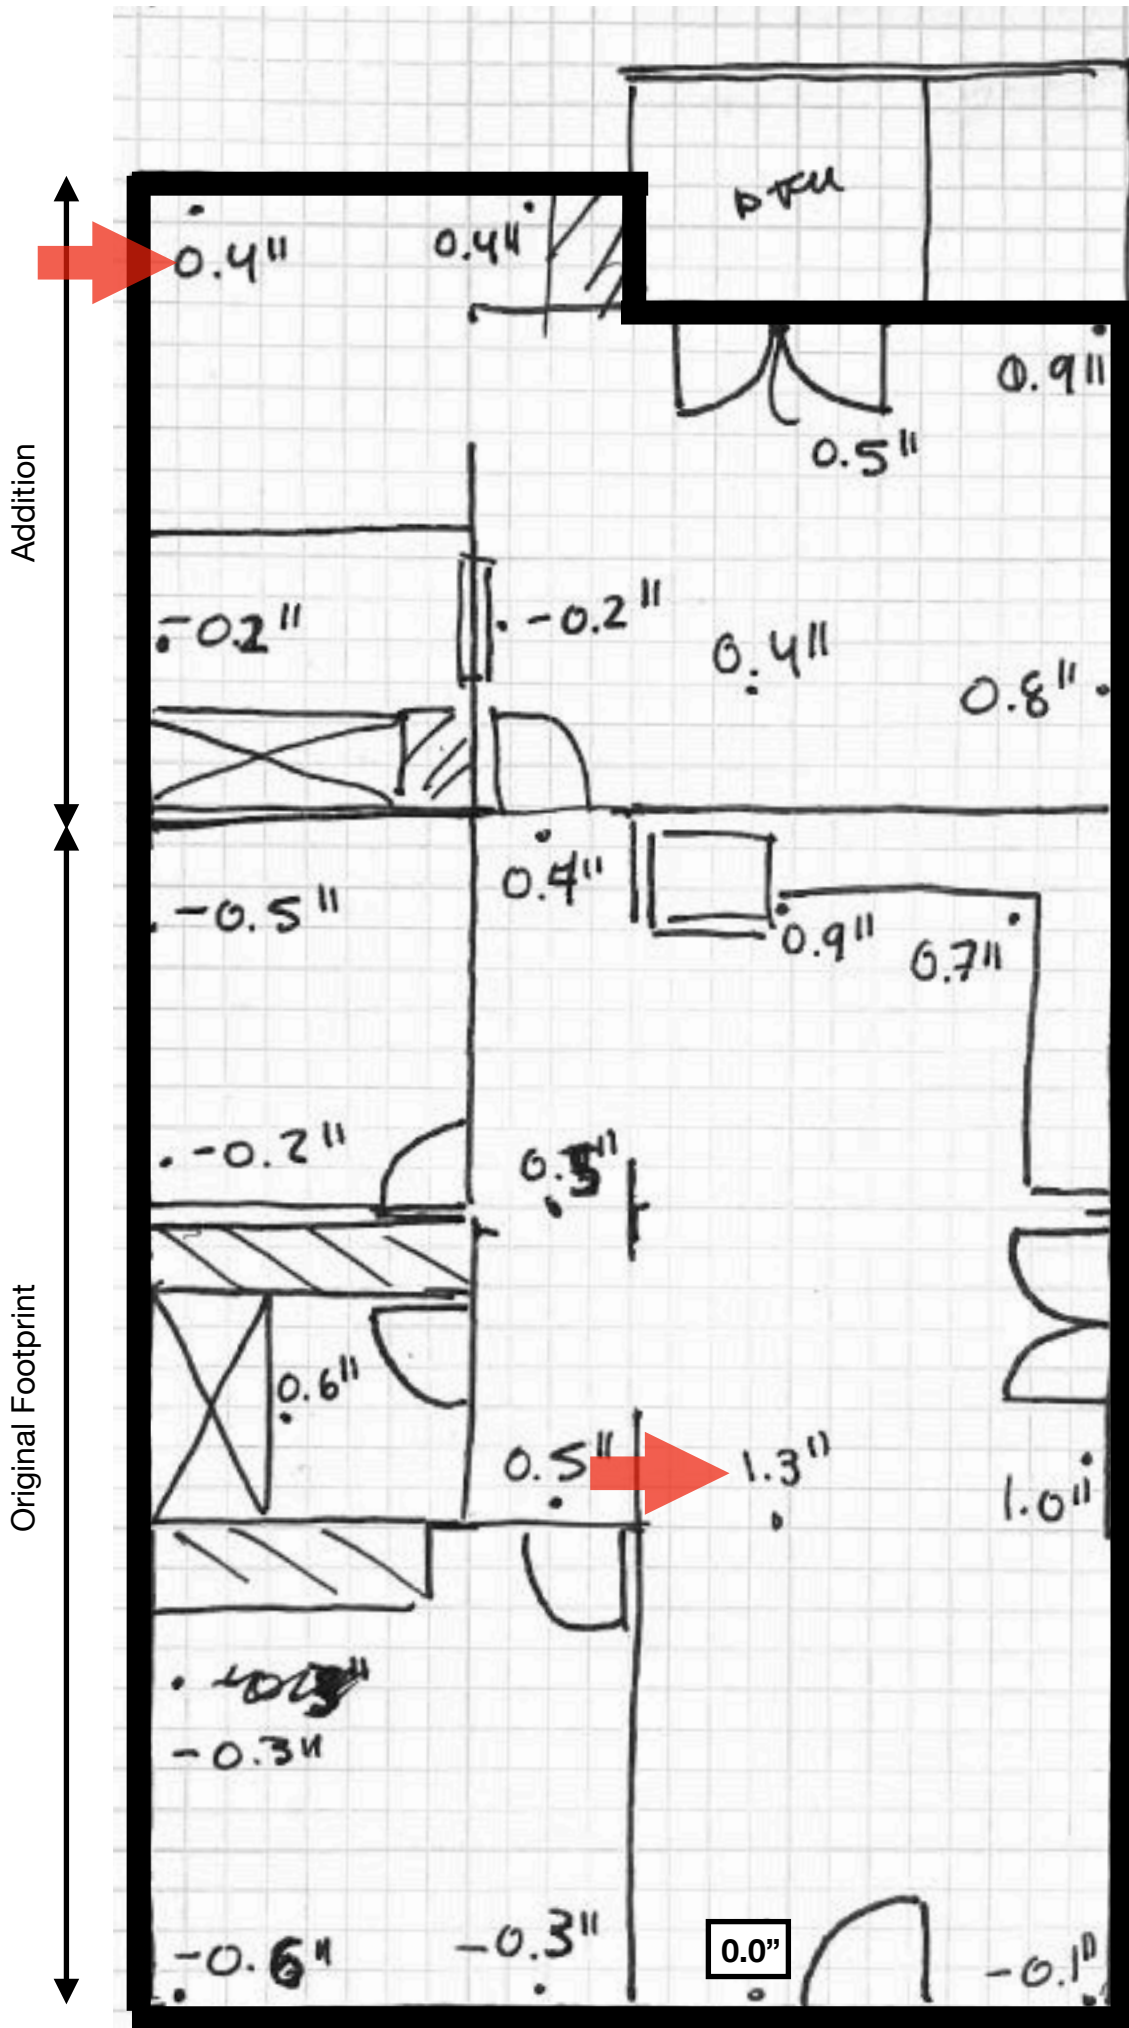
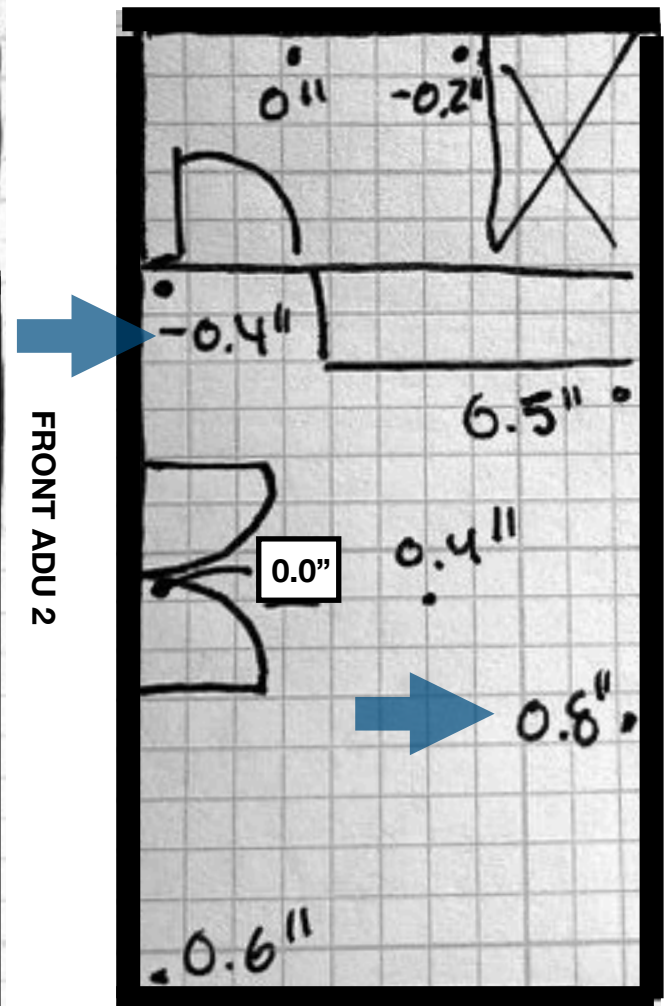
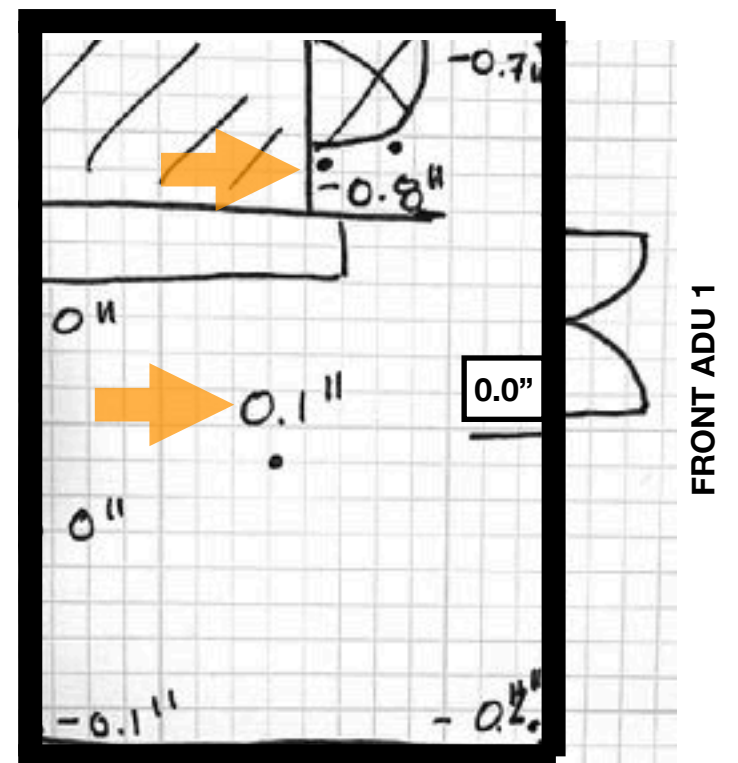
- The interior floors were spot checked for levelness using a Zipline, a high precision digital altimeter.
- The maximum elevation change was observed to be 1.7", 0.9", and 1.2" between the red, orange, and blue arrows shown at the main building, ADU 1, and ADU 2, respectively.

- The final decision will depend on the owner and be a subject determination. The minimum recommendation is:
 - Ensure surface water is controlled around the property as well as possible as water combined with expansive soils can contribute to foundation settlement.

- Patch existing cracks and monitor for future ones
 - Use this survey as a baseline for future readings to see if there is active movement occurring.

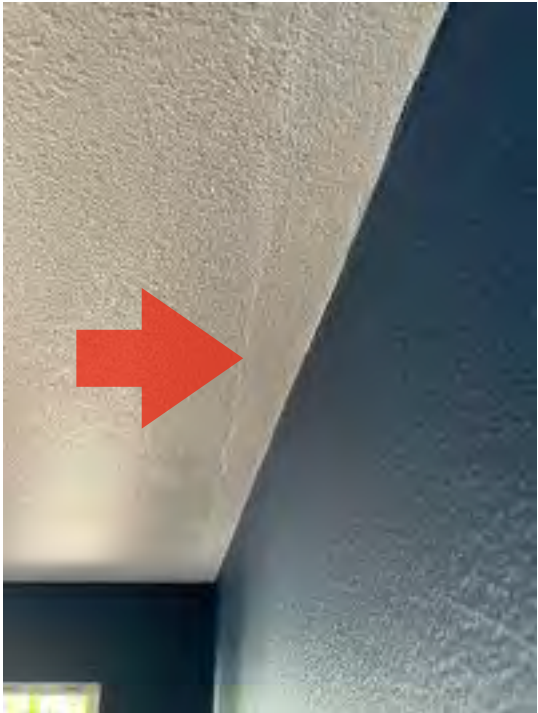
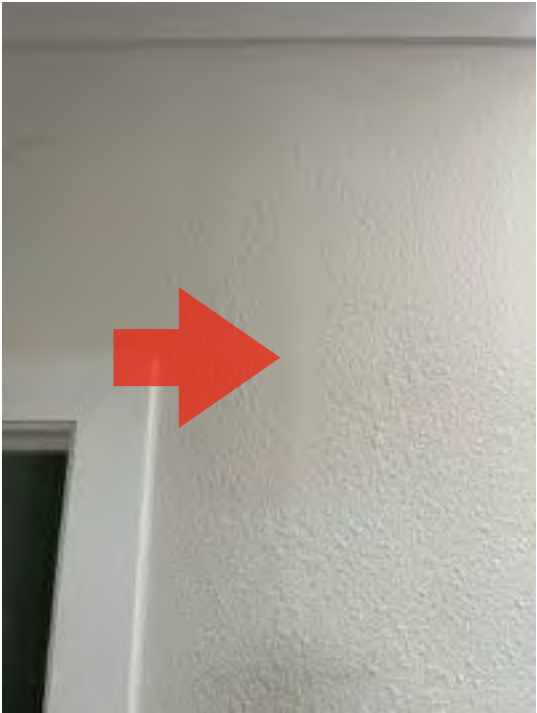
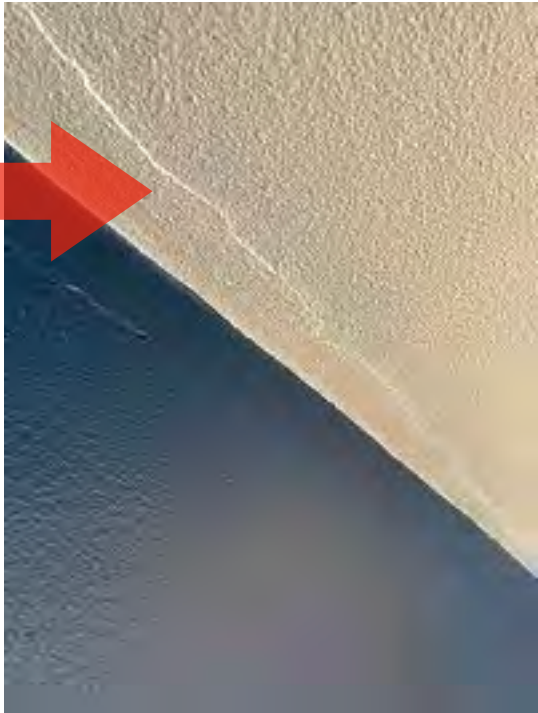
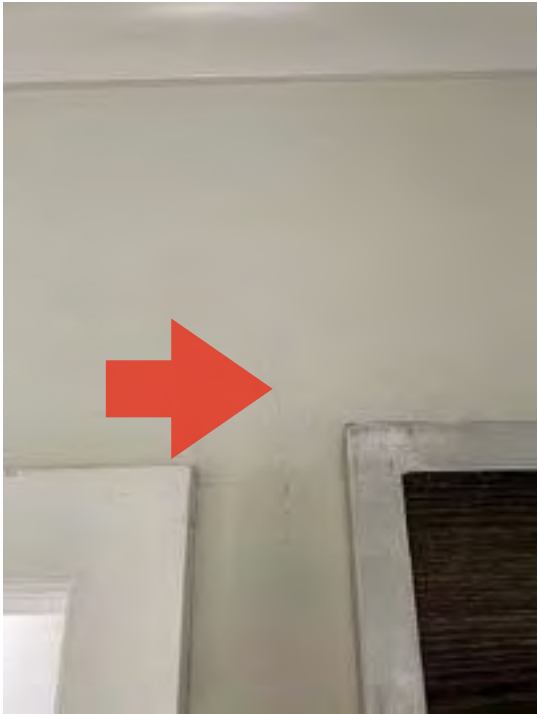
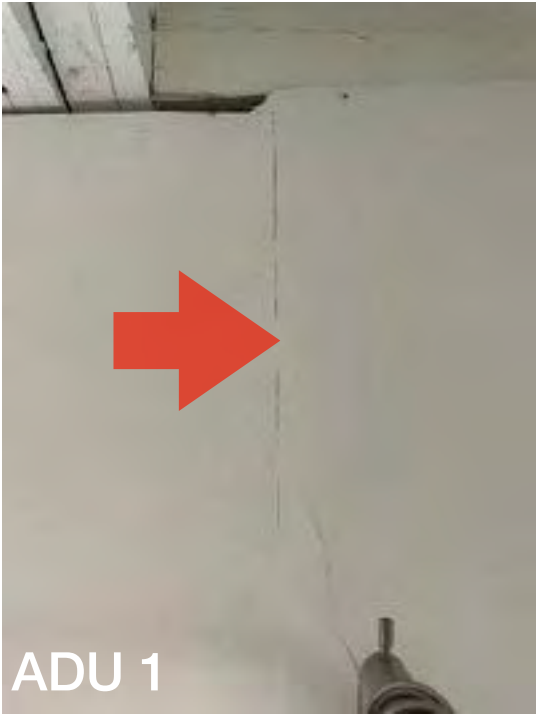
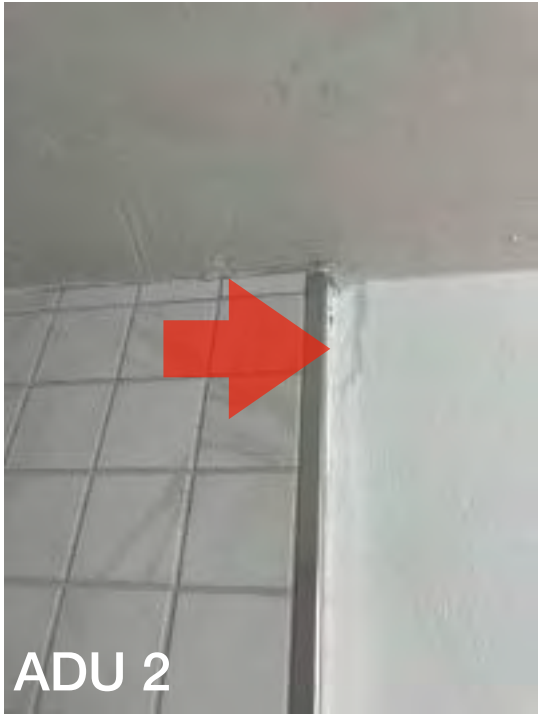
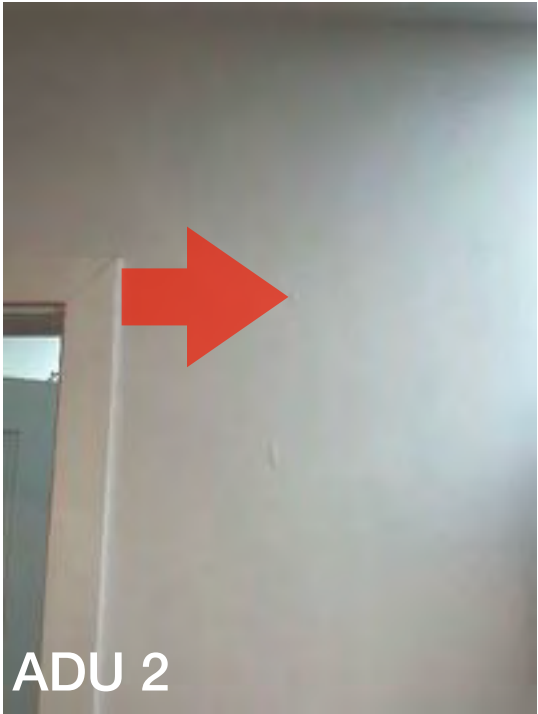
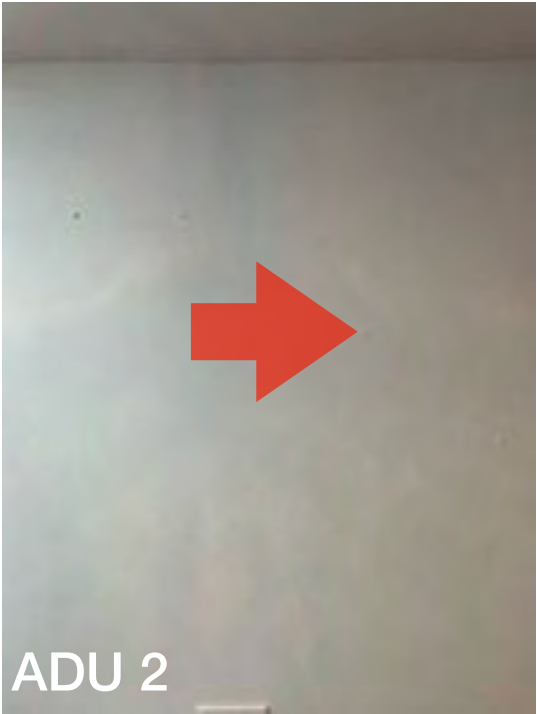
- There were a few interior indications that could be consistent with minor foundation movement as shown in the pictures above, but these were relatively minor. (note: we do not necessarily take a picture of every crack, rather a representative number).

- The exact cause of the movement is unknown. Only a soils report with deep borings & lab analysis can provide the data necessary to fully analyze (this process is naturally quite expensive) - see Attachment 9 for a list of potentially contributing factors.

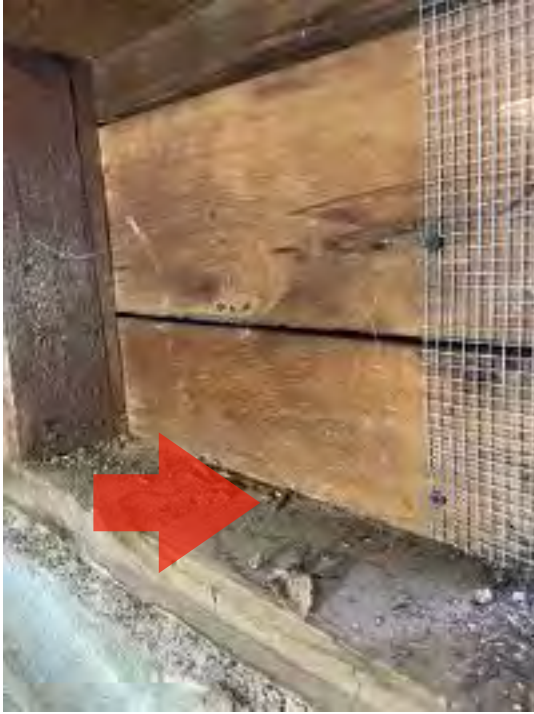
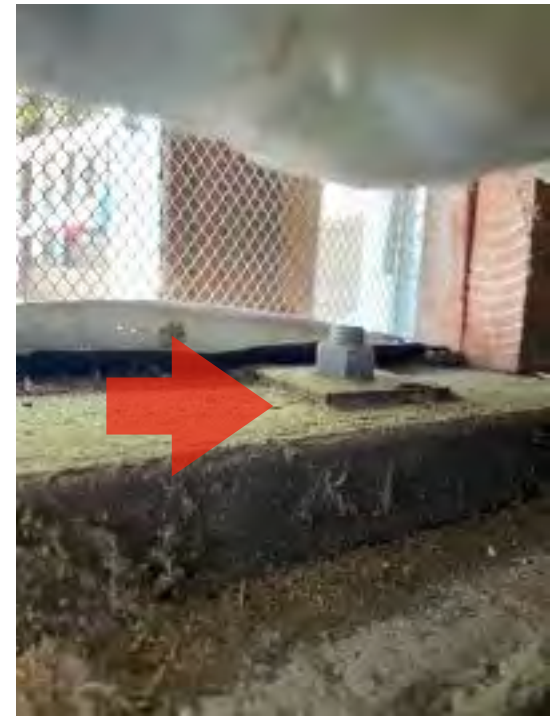
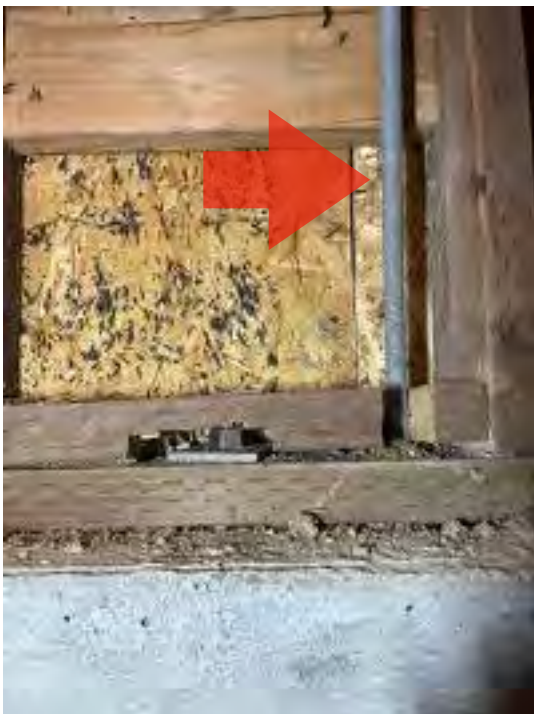
- **Observation Details:** The property is located in a **high seismic region**. Please refer to Attachment 4 for additional information. Within the original footprint of the home the cripple walls are horizontally sheathed, and no shear anchors were observed (images 1 and 2). This is not uncommon for homes of this age. In the back addition anchor bolts with heavy plate washers and hold-down anchors were observed, which is consistent with construction from the 1990s or more recent. The seismic status of the house appears consistent with the age of construction.

- **Options:** As desired, **more comprehensive seismic upgrades could be installed to the sub-structure area**.
 - Additional foundation anchors could be installed between the mud sill and foundation.

- Plywood bracing could be installed to the inside face of the wood framed cripple walls where missing.
 - These recommendations are detailed in the pre-engineered plan set for single family homes in the Applied Technology Council (ATC) report “Seismic Rehabilitation Guidelines for Detached, Single-Family, Wood-Framed Dwellings” (document ATC-50-1). Additional information can be found at the following: Earthquake Brace & Bolt (California Residential Mitigation Program) www.earthquakebracebolt.com, California Earthquake Authority www.earthquakeauthority.com & Quake Prepare www.quakeprepare.com.

- **Recommendation:** In general it is best to retrofit homes, in particular, we recommend adding shear anchors and plywood sheathing within the original building footprint.

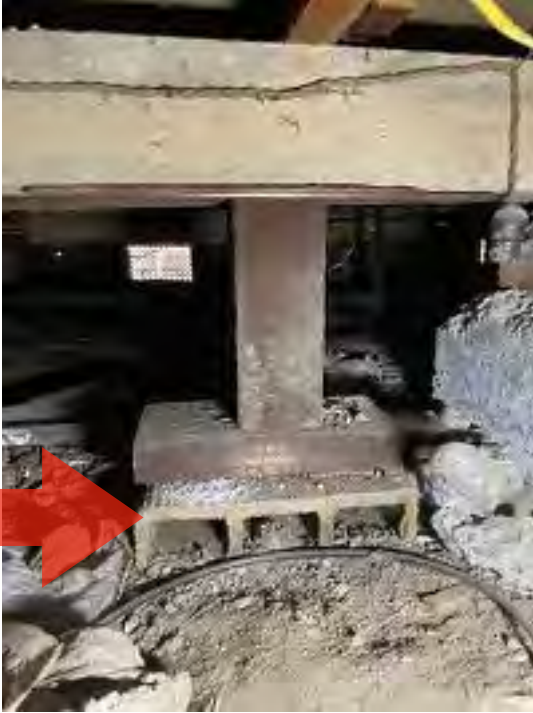
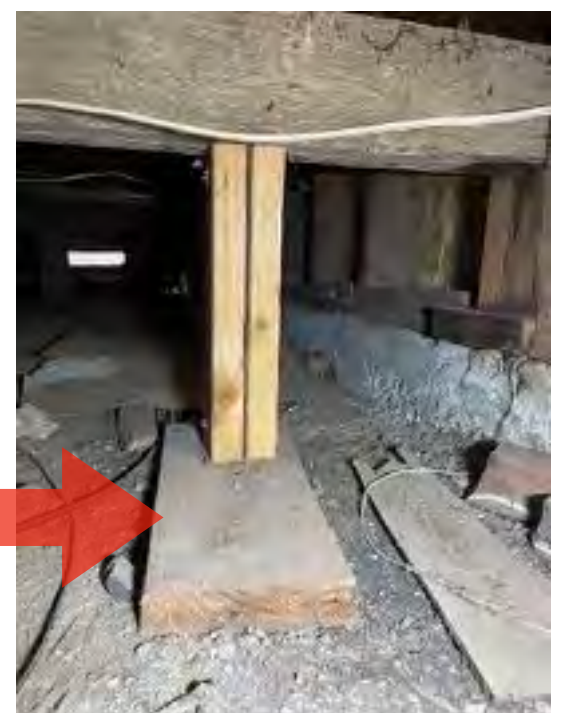
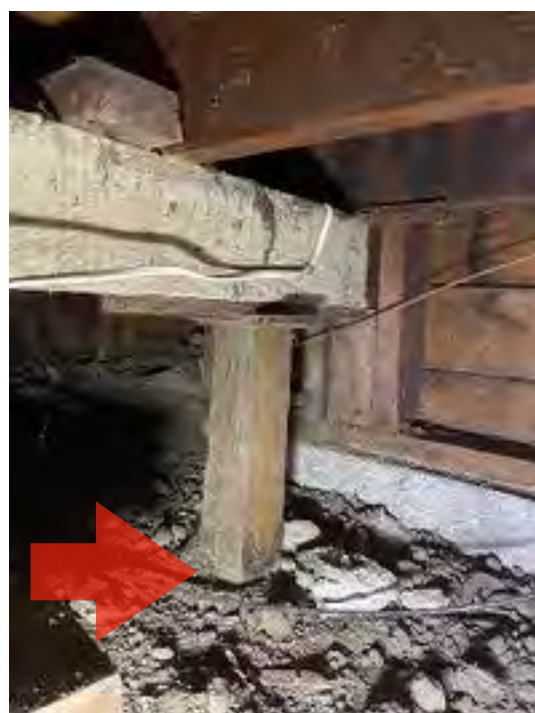
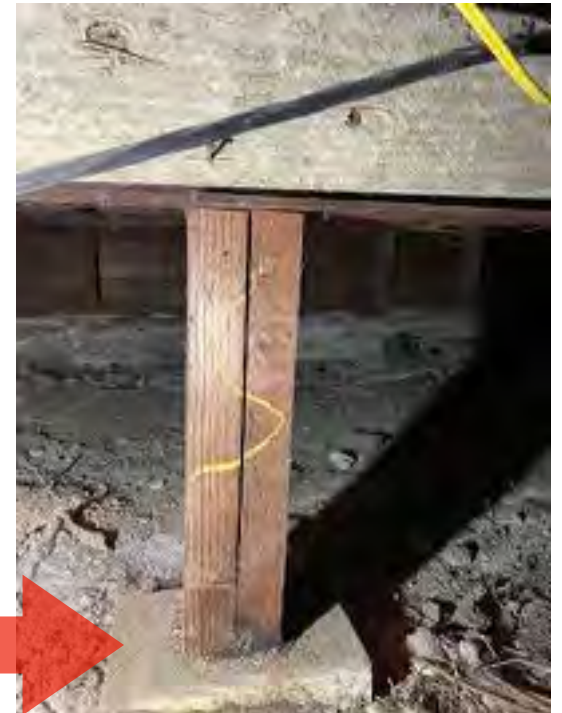
- **Observation Details:** The concrete footers pictured here are either insufficient or non-existent.
- **Options:**
 - **Option 1:** Install proper concrete footer and new post built per modern construction standards. Typical isolated spread footers are 24" cubed with a minimum 18" embedment depth; budgetary cost range \$2.5K +/- 30% per footer
 - **Option 2:** Install surface mounted concrete footers with nominal embedment and replace post for a lower cost option; budgetary cost range \$500 +/- 30% per footer.
- **Recommendation:** We would suggest Option 1 budget permitting.

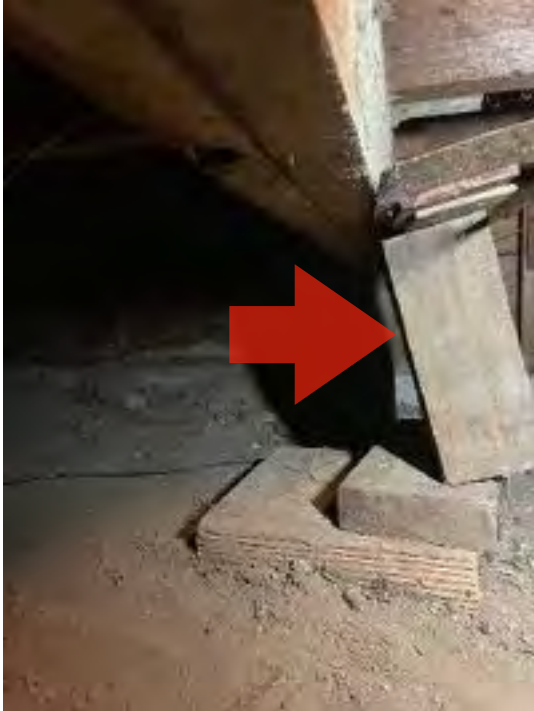
Item Image 1

- **Observation Details:** The support post above had shifted away from the beam and is no longer providing vertical support. The post appears as though it may have been added to stiffen the floor structure. The movement is likely due to movement of the soils below and potentially from a past impact load.
- **Options:**
 - Option 1: Install proper concrete footer and new post built per modern construction standards. Typical isolated spread footers are 24" cubed with a minimum 18" embedment depth; budgetary cost range \$2.5K +/- 30% per footer
 - Option 2: Install surface mounted concrete footers with nominal embedment and replace post for a lower cost option; budgetary cost range \$500 +/- 30% per footer.
- **Recommendation:** We would suggest Option 1 budget permitting. The condition should be addressed in the near term.

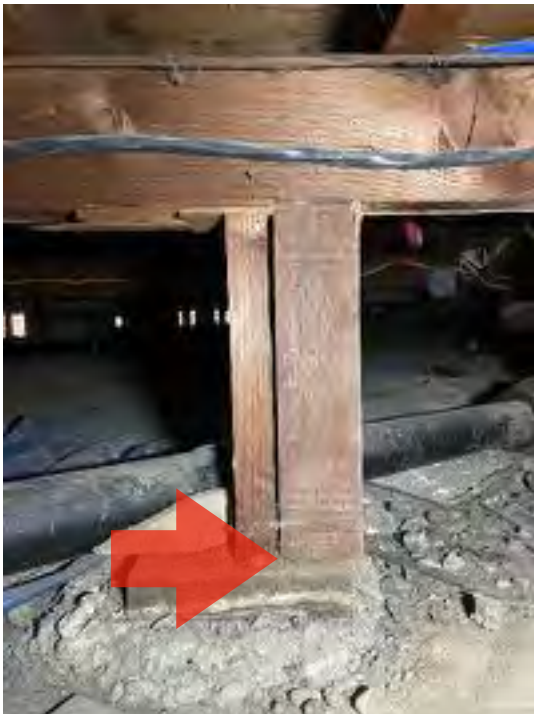
Item Image 1

- **Observation Details:** The post shown above is not lined up with the foundation block below. Adjacent posts are lined up so it's likely not related to movement but rather an initial construction flaw.
- **Recommendation:** There is enough space on the concrete so the support wood base could be moved over and stay fully bearing on the concrete below (handyman or DIY repair - minimal cost item).

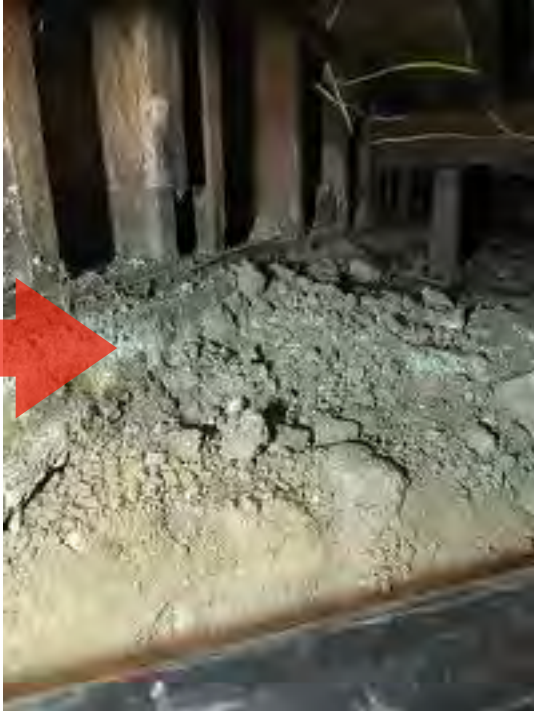
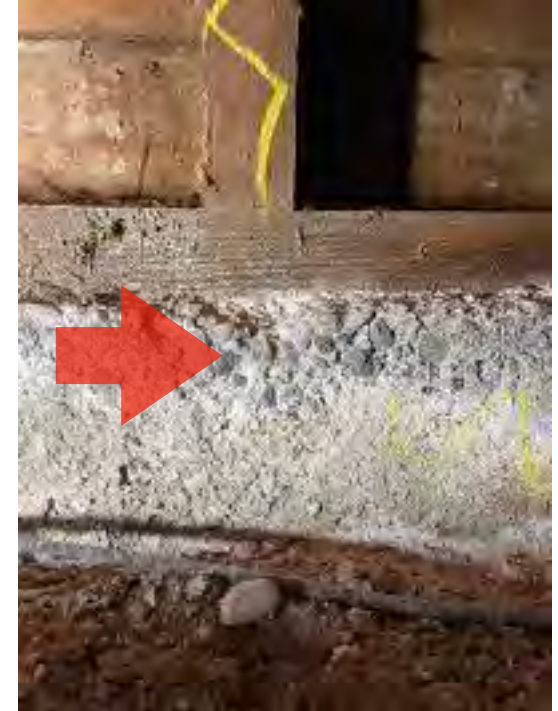
- **Observation Details:** There are various forms of spalling but this one is the result of the chemical breakdown of the cement within the concrete mix (rock, sand, cement). Typical causes of spalling concrete include but are not limited to the following: excessive moisture and/or poor site drainage conditions, poor quality cement used in the concrete mix, the ratio of cement with relationship to the amount of sand and rock in the concrete mix is too low & the sand used in the concrete mix has excess salt-mineral residue. We can see one area on the left side as shown in Image 6 where it appears a portion of the foundation was capped (the background and purpose of this is unknown).

- **Recommendations:**
 - A reasonable first step would be to survey the strength of the existing footers with non-destructive rebound hammer testing to document the concrete strength and identify locations of severe spall. This would provide objective reference data of the concrete strength to compare against every 3-5 years.

- From the test data and subsequent follow-up testing the appropriate timeframe for a future foundation replacement could be more appropriately determined.

- Based on what we observed, and comparing it to other houses of the age, we do not think that replacement is necessary in the near term, but could be in the distant future. Again, future testing/data and analysis is required to arrive at a timeframe for such a replacement, a budgetary cost range for replacement would be around \$1.5K +/- 30% per linear ft, for a house of this size it would likely be in excess of \$120K, you would need to see out quotes from at least contractors for such work.

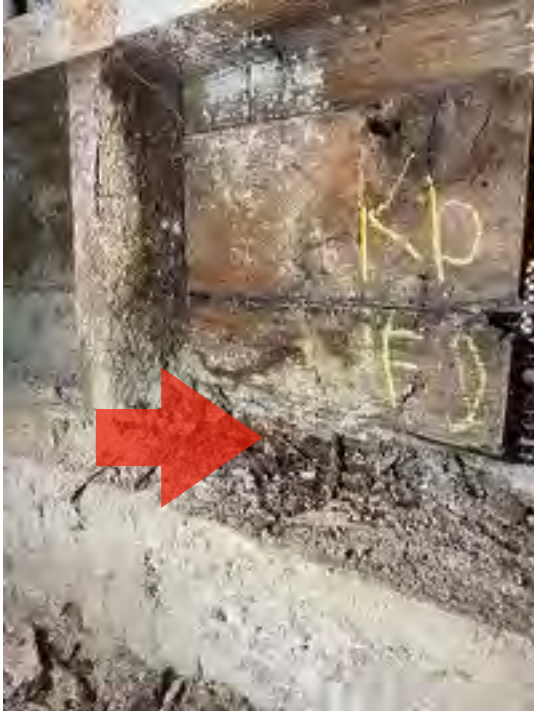
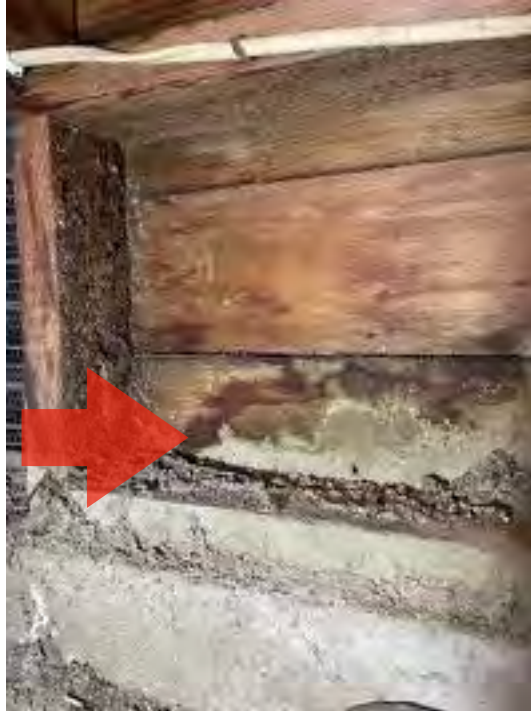
- **Observation Details:** Water damage and signs of rot observed at mudsill and horizontal sheathing as shown in the images above underneath to the right of the home.
- **Why it's important:** Water damage and rot can lead to loss of structural integrity.
- **Recommendation:**
 - Wood should be cleaned and treated to prevent any continued rot, and significantly damaged elements should be replaced in like kind. A pest and wood eating organisms inspection by qualified professionals is recommended and we would defer to their recommendations.
 - **Implement drainage recommendations** in report (see subsequent sections).

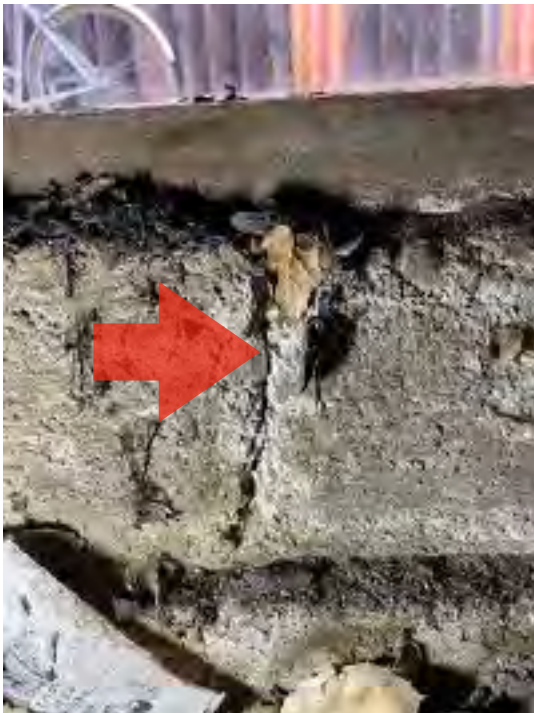
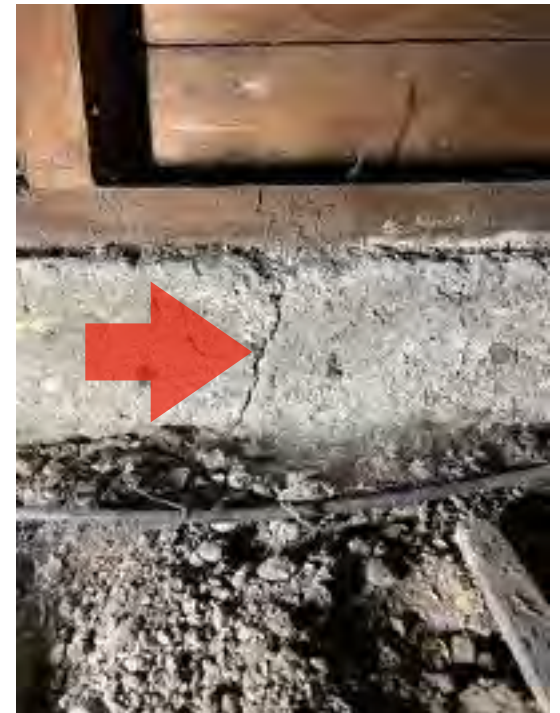
- **Observation Details:** These cracks generally occur from a combination of shallow foundation embedment depth and expansive soils which will swell when wet and contract when dry (see Attachment 2), foundation settlement, or past seismic activity.
- **Severity:** There were approximately 3 cracks 1/8" or less.
- **Options:**
 - Option 1: Mark & monitor (negligible cost - homeowner or handyman repair).
 - Option 2: Cover the crack surface with epoxy (\$200 +/- 30% per crack - homeowner or handyman repair).
 - Option 3: **Inject structural epoxy under pressure into the crack** (\$500 +/-30% range per crack - qualified contractor repair).
- **Recommendation:** We'd recommend Option 3 in which the total budgetary cost range would be \$1.5K +/- 30%.

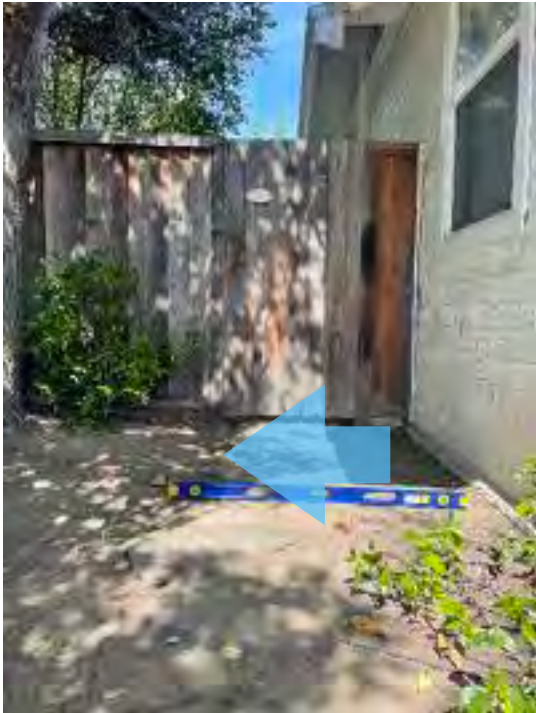
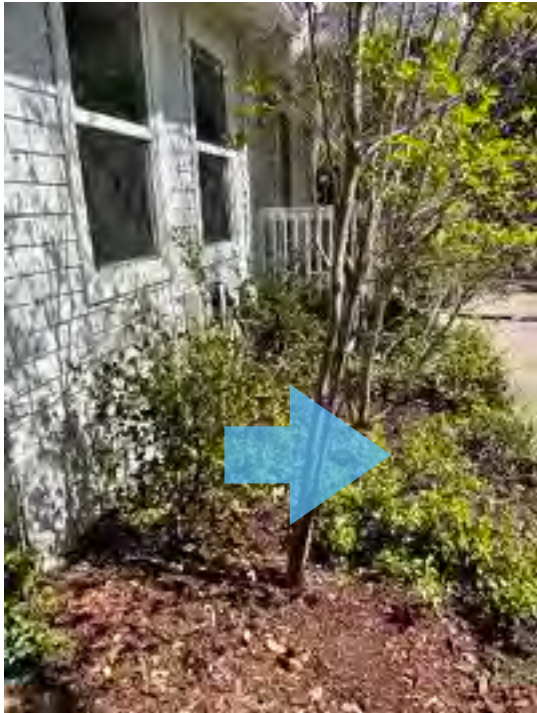
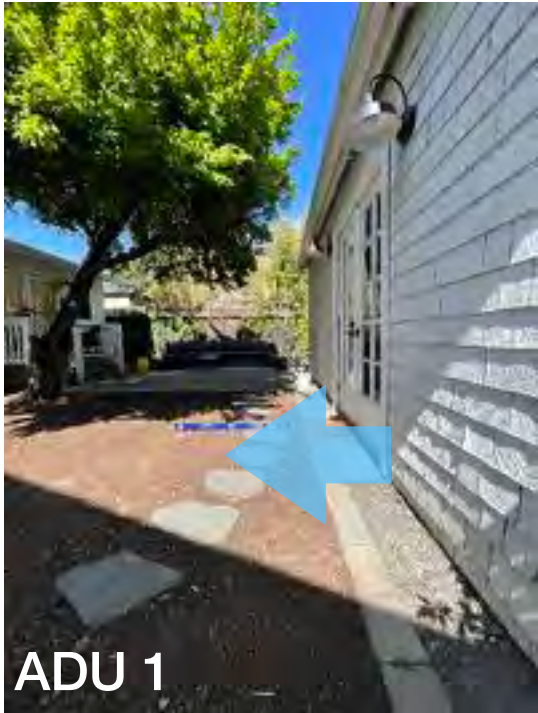
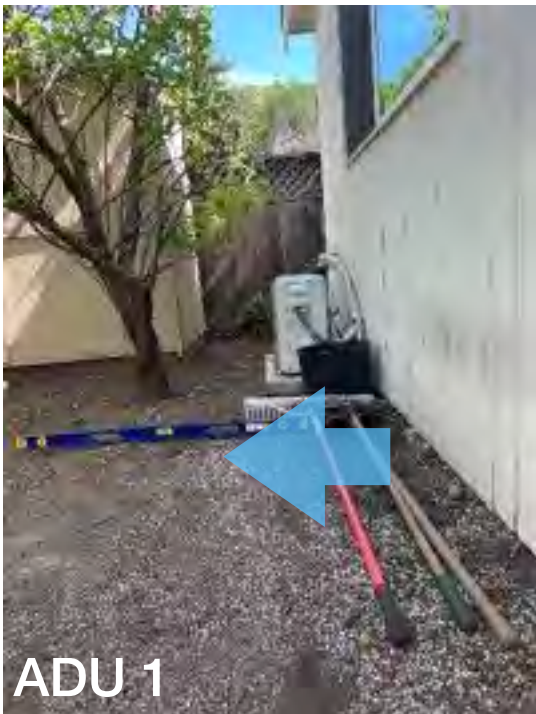
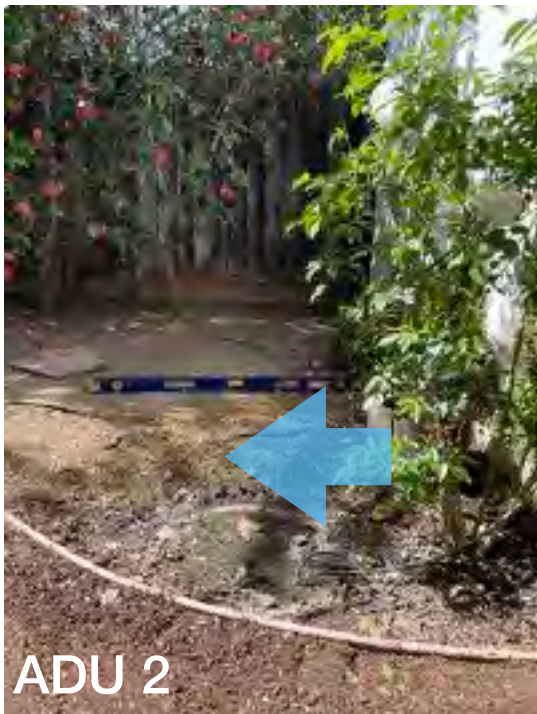
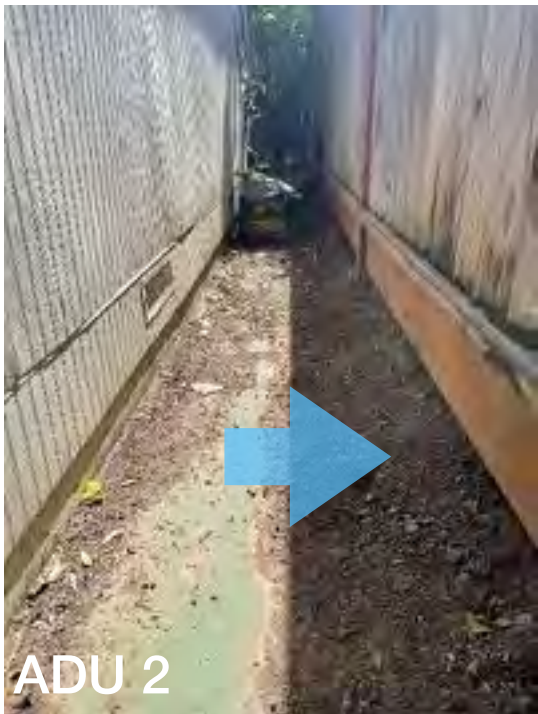
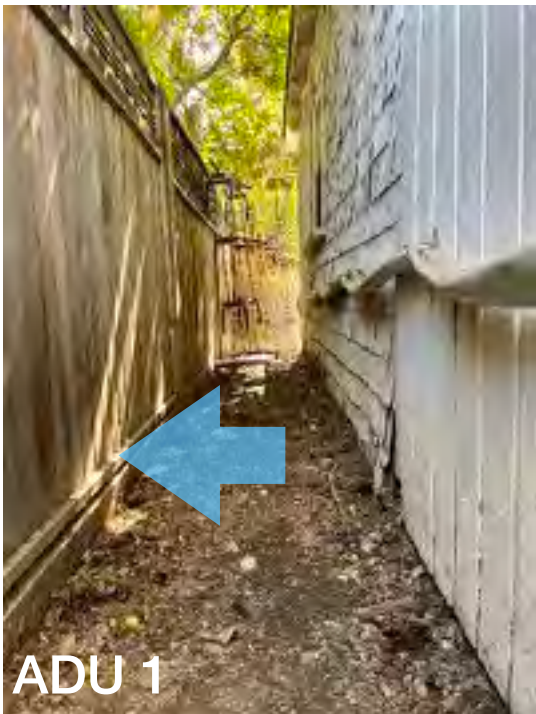
- **Observation Details:** It is recommended to ensure adequate slope away from the house in all areas such that surface water will flow away from the foundation. Arrows in the images above show the direction that water should be flowing.

- **Options (see Attachment 3 for illustrations):**
 - Option 1: **Re-grade the soil** around the structure to slope away from the foundation, this is generally a relatively minimal cost and can be either DIY or accomplished by competent landscaping companies.

- Option 2: **Install hardscape** (i.e. impervious surface such as concrete or tightly spaced pavers) to slope away from the foundation; budgetary cost range per side of an average sized house would be \$5K +/- 30%.

- Option 3: Install subsurface drainage (French Drains or similar) to minimize the water near the foundation (full french drains around an average sized house might be in the \$40K +/- 30% range).

- **Recommendation:**
 - In this case, a combination of Option 1 & 2 would be a good first step that is easy to implement. Given the age of the home and the observations in the report, subsurface draining per Option 3 would be a beneficial for the home in the long term.

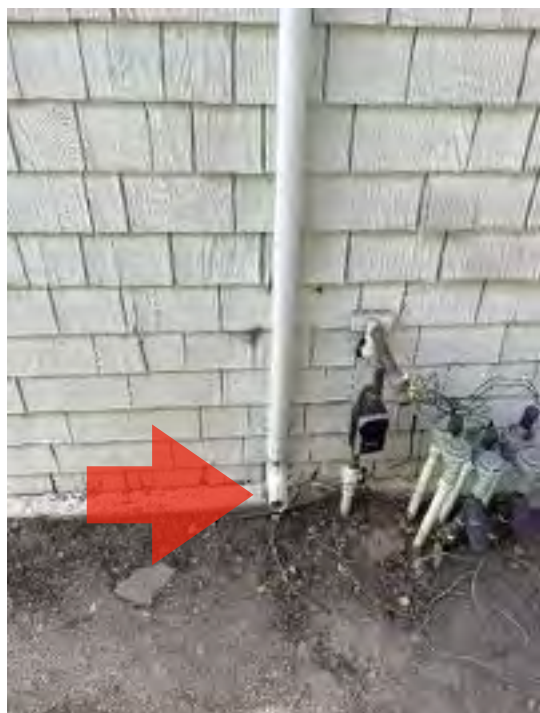
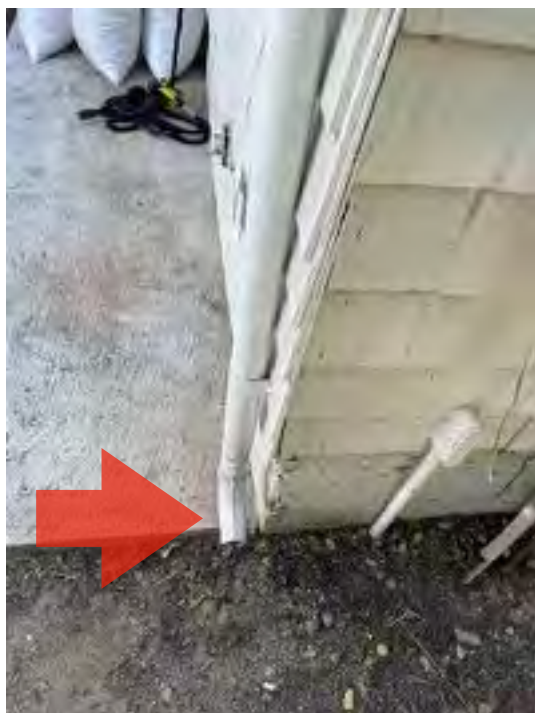
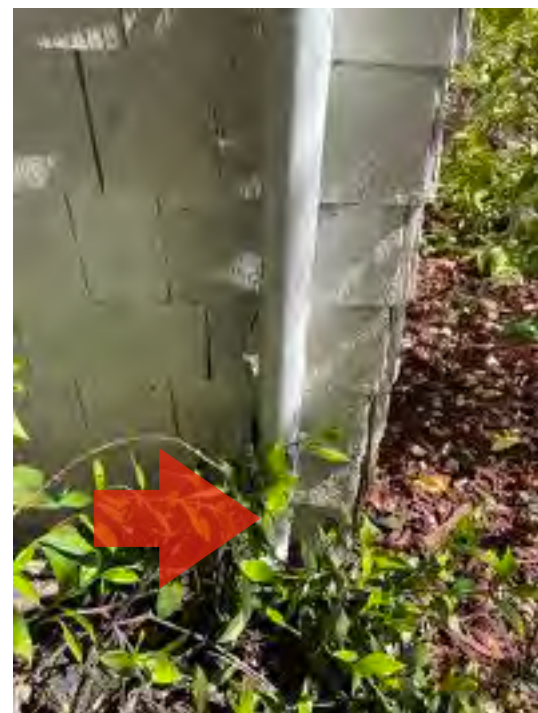
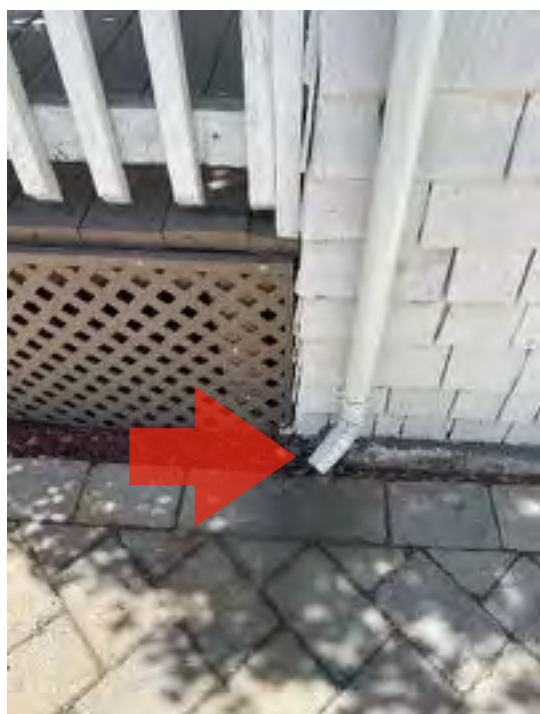
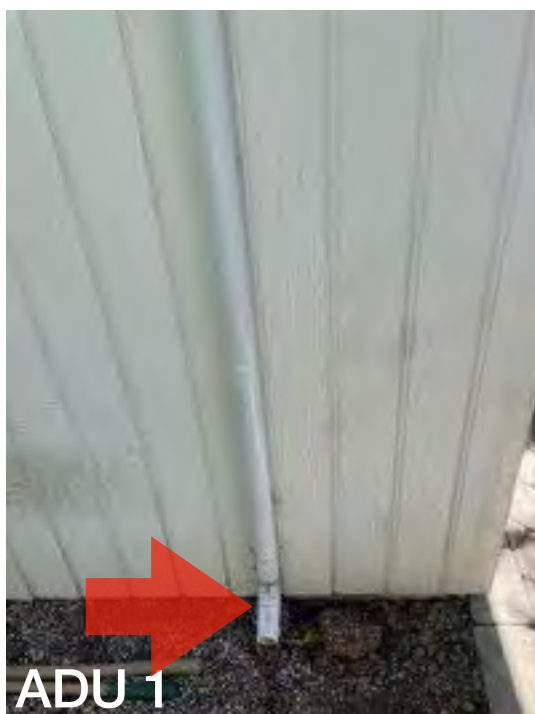
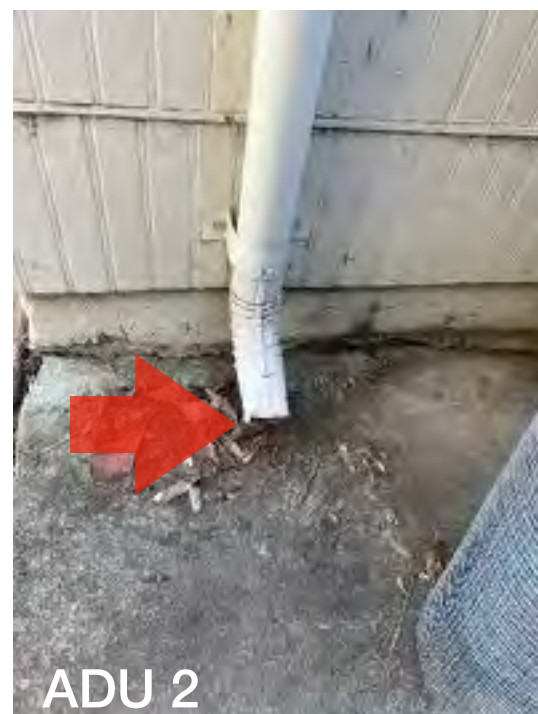
- **Observation Details:** It is important that water from the roof flows away from the foundation a safe distance. Water control around properties is very important.
- **Options:**
 - Option 1 - Add extenders to discharge water at least 5' from the house.
 - Option 2 - Add hardscape and discharge onto hardscape that then flows away from the foundation at least 5'.
 - Option 3 - Discharge into hard piping which is then routed to discharge water a safe distance from the foundation.
- **Recommendation:** In this case, we would recommend using extenders per Option 1.

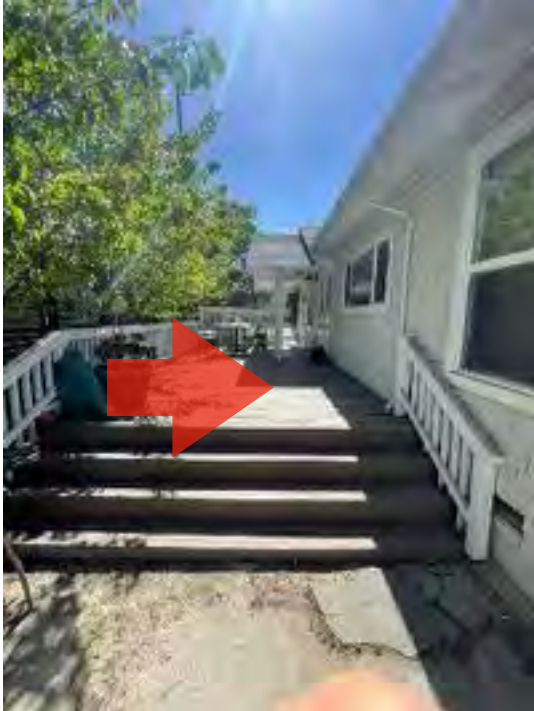
Item Image 1

- **Observation Details:** It is recommended to ensure adequate slope away from the house in all areas.
- **Options:**
 - Option 1 - Add hardscape below the deck that slopes away from the foundation.
 - Option 2 - Add roof over the deck.
 - Option 3 - Slope the deck & cover with impermeable surface.
- **Recommendation:** We would recommend any of the above options at the owner's discretion and the final budgetary cost will depend on the approach taken.

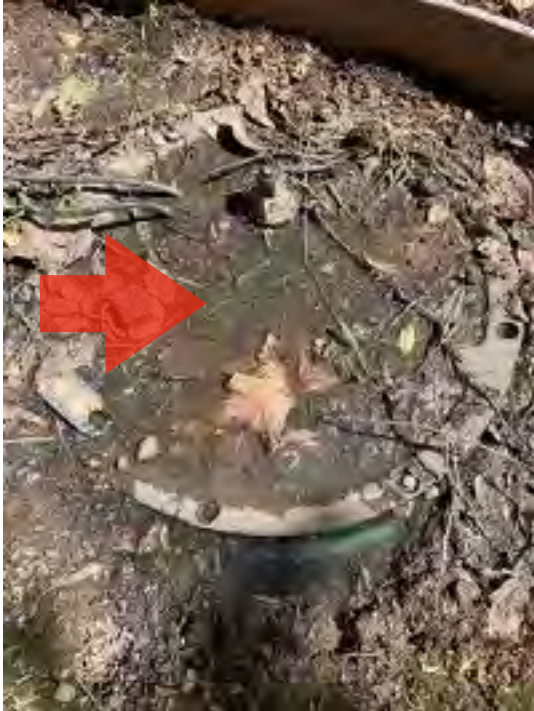
Item Image 1

- **Observation Details:** The crawlspace was dry, but there were some signs of past water, particularly in the back areas of the home, and there is a sump pump in front of the back left ADU. The pit was full of standing water and the pump was clearly inoperable. The signs of past water and pump could be a rising of relatively high water table, or could also be due to past surface water (we suspect the former with seasonal variation). The full background and hydrogeology of this could only be ascertained through a soils report and further research, which is beyond the scope of this report but not uncommon in some areas.
- **Recommendation:**
 - Implement drainage recommendations in report.
 - Have sump pump serviced as part of regular home maintenance.
 - Monitor, in particular during winter months after heavy rain events when the water conditions will be more apparent.

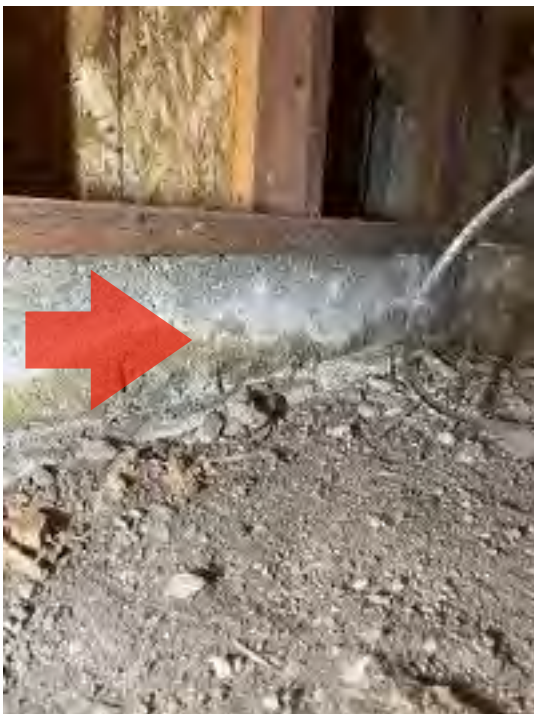
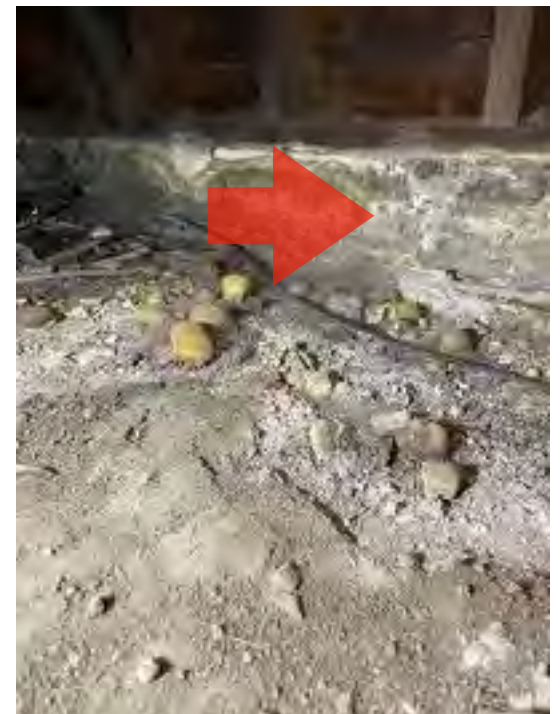
- **Observation Details:** Efflorescence is an indication of excessive moisture that appears when water that contains soluble salts evaporate from the surface of the foundation, resulting in a crystalline salt deposit. The deposits are usually white but they can also be green, brown, or gray depending on the mineral composition.
- **Severity:** Not a severe condition in and of itself but can be an indication that improved drainage improvements are necessary. Note: this is a very common condition and we do not take pictures of every location, just a couple to help illustrate the extent.
- **Recommendation:** Performing the recommended drainage improvements would help limit the amount of water (and hence this condition), so the recommendation is to make the drainage improvements and monitor.
