FOUNDATION & DRAINAGE INSPECTION REPORT

1111 Alma Street, Palo Alto

Inspection Date: 4/4/2022

Address: 1111 Alma Street, Palo Alto

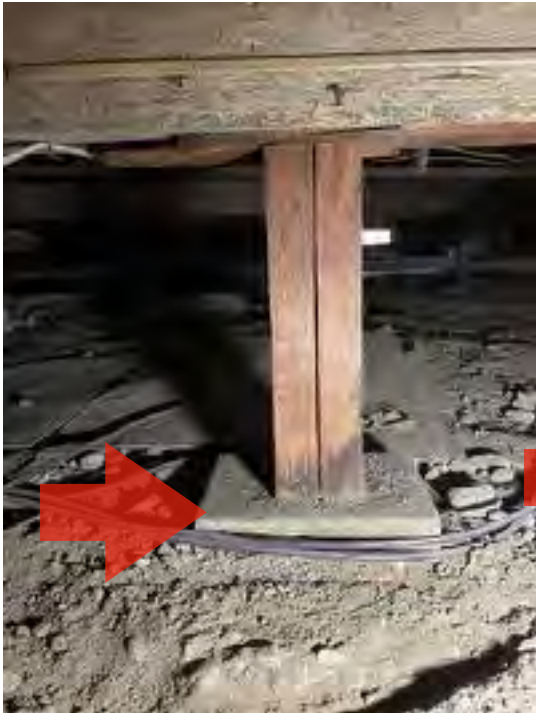
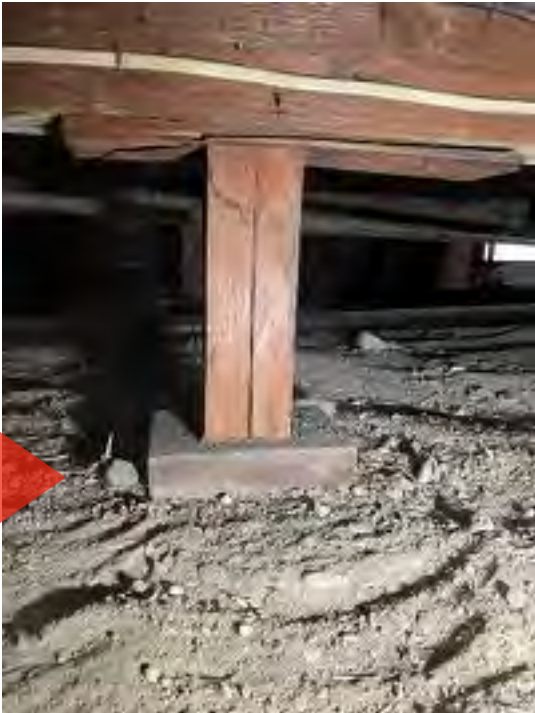
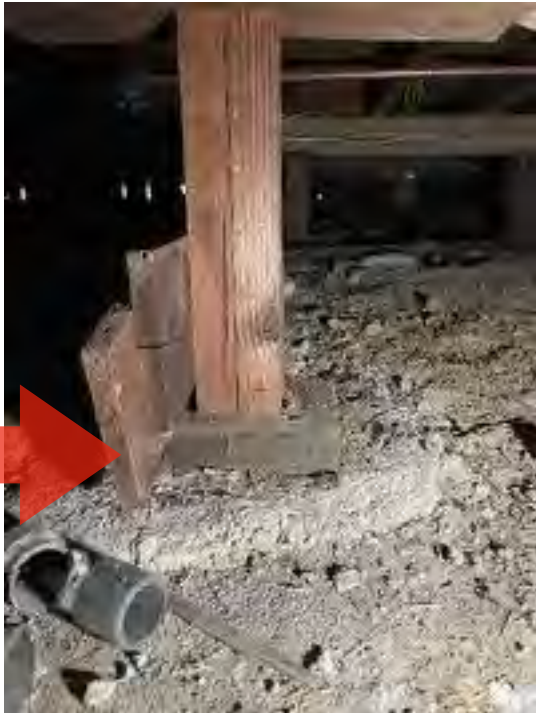
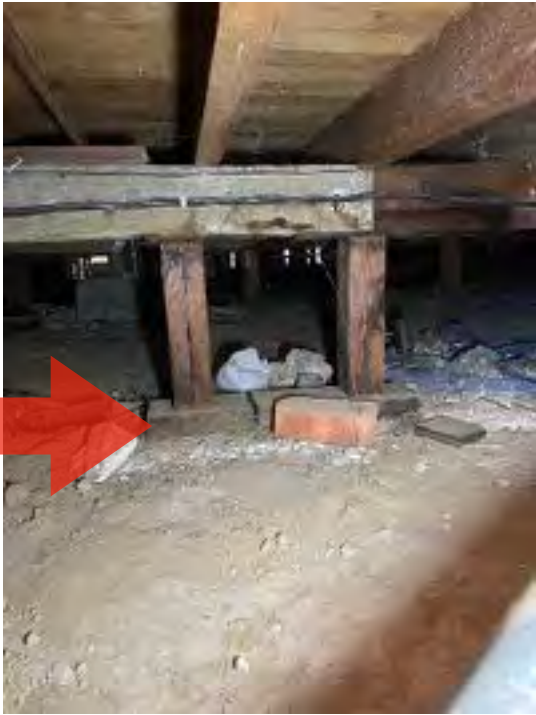
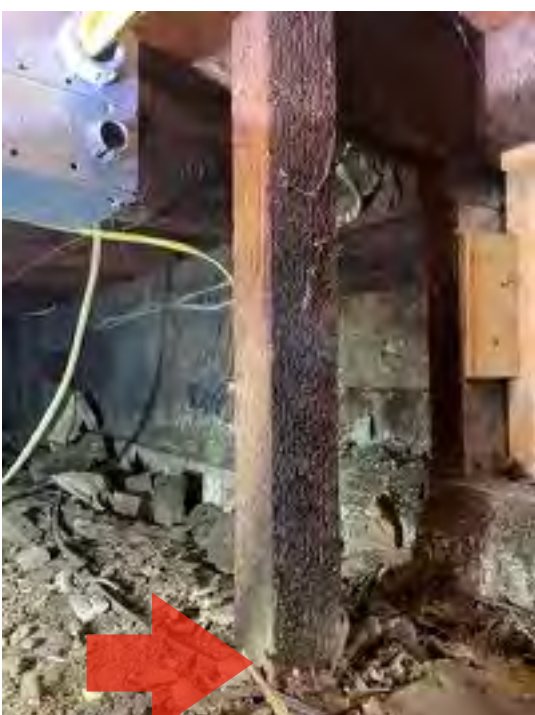
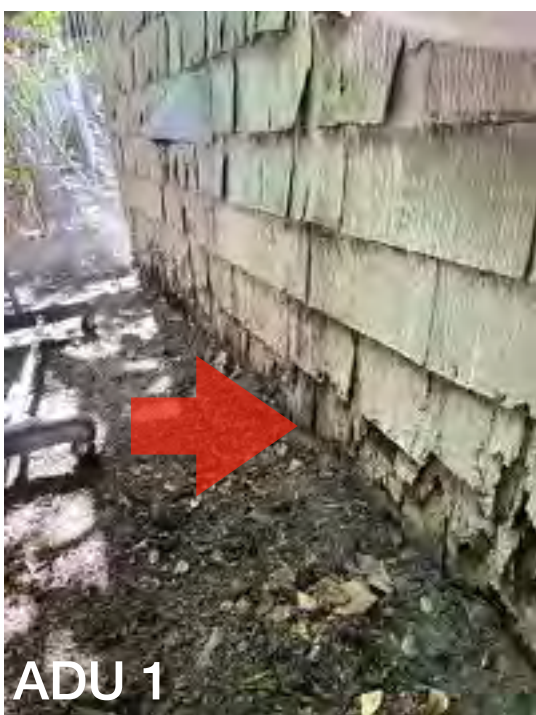
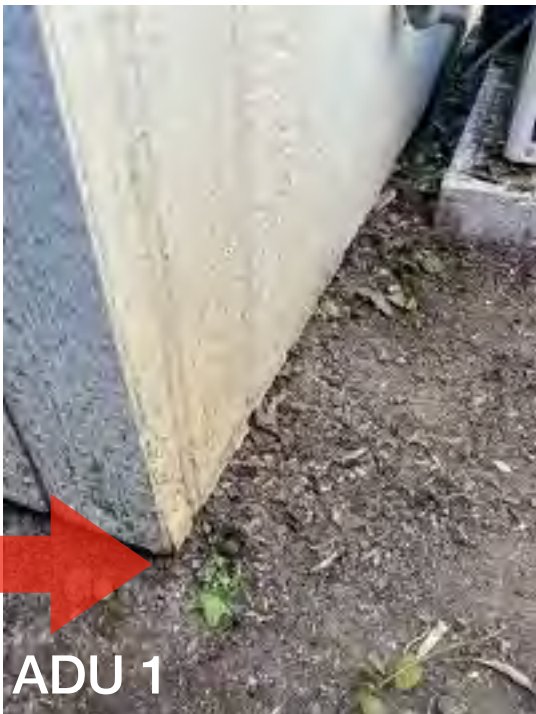
- **Observation Details:** Soil is near to the wood in the areas shown. The concern would be increased chances for rot and/or termite activity with the wood to soil contact (refer to termite inspection reports for observations & recommendations).
- **Recommendation:** Soil in these areas should be brought down to a lower height to give at least 6 inches of clearance (if possible) - relatively minor cost and can be a handyman or homeowner project.

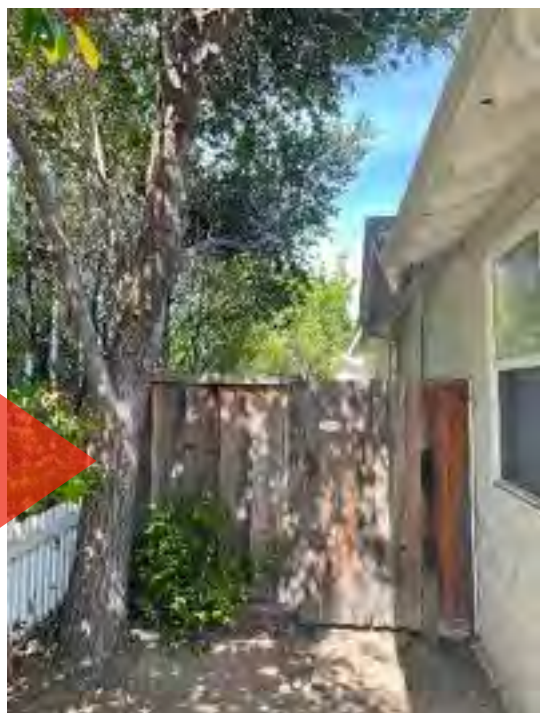
Item Image 1

- **Observation Details:** The tree shown is marginally close to the foundation and should be monitored. No direct issue was noted at the present.
- **Recommendation:** Keep an eye out for any interior cracking or sloping floors in the area of the tree and if desired, consult with an arborist for their recommendation relative to this species of a tree and their experience.

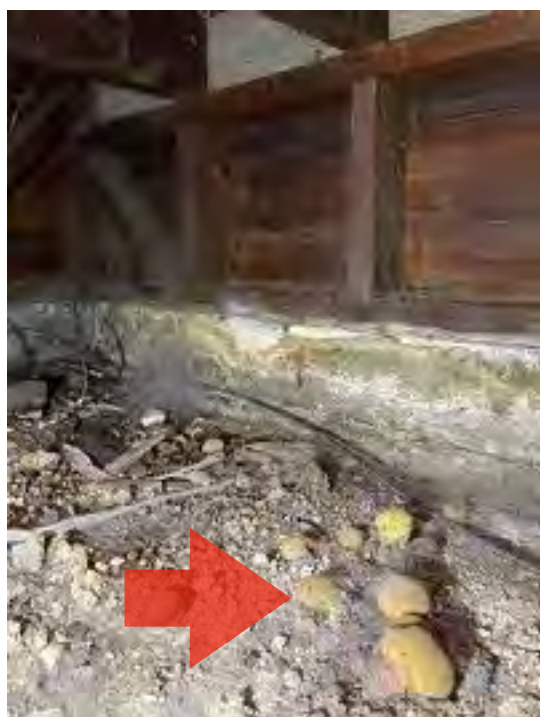
Item Image 1

- **Observation Details:** Towards the front right corner of the home, what appears to be fungal growth was observed.
- **Recommendation:** We are not sure what the growth is, but we would recommend having crawlspace cleaned and monitored.

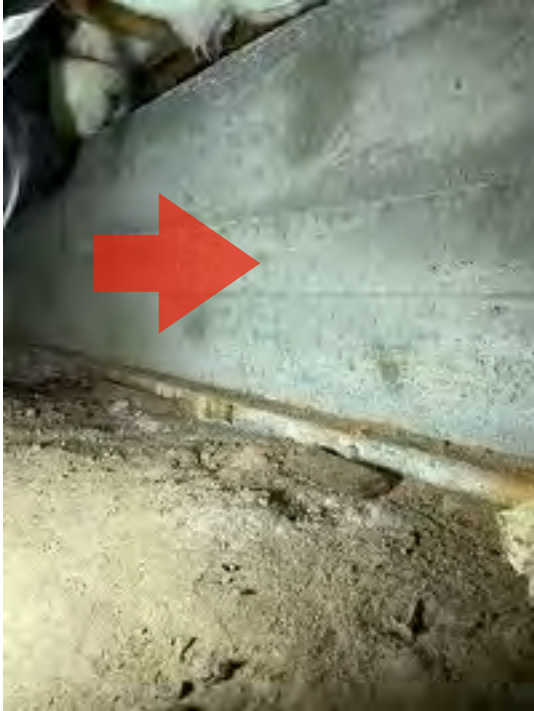
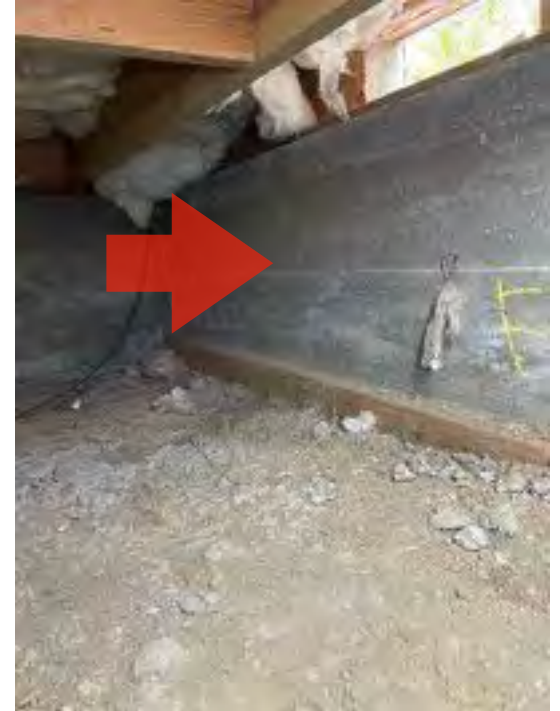
- **Observation Details:** As noted in the introduction and shown in the images above there was an addition in the back of the home. Foundations are much more modern on all sides of the foundation. We received no details of the past addition, but suspect the work may have been completed in the early 2000s.
- **Recommendation:** No action necessary beyond being aware of the past work, and trying to track down the construction record with the local building department.

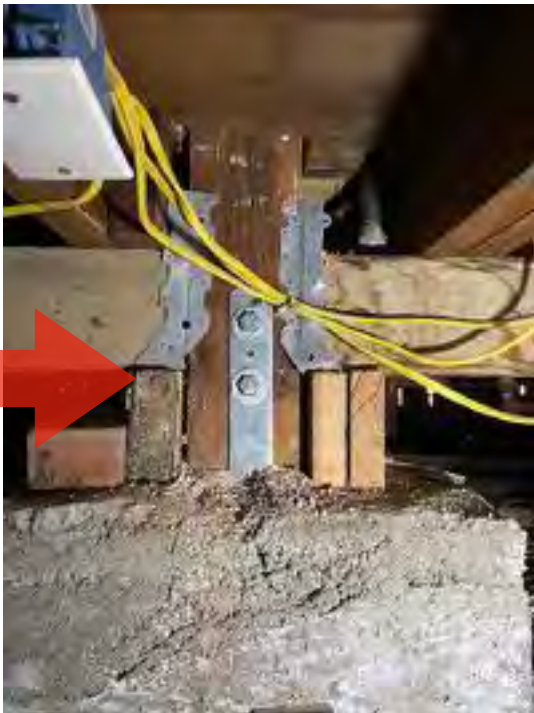
Item Image 1

- **Observation Details:** Toward the middle of the original building footprint, we observed a column that was added in the past, and the floor beam spliced to each side of the column as shown in the image above. It is unclear when this work was completed, but it appears older than the back addition. The reason for the added column is unclear, potentially the interior wall framing was altered in the past.
- **Recommendation:** No action necessary beyond being aware of the past work, and trying to track down the construction record with the local building department.
