# **Home Inspection Report**

2878 Richgrove Ct, San Jose, CA 95148

CHE050922PF

Monday, May 9th 2022

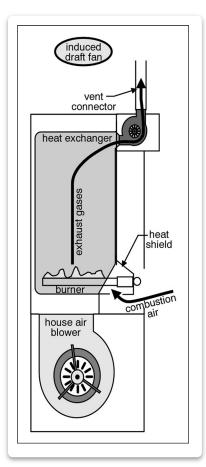
UPGRADE As commonly found in homes of this age, a sediment trap at the pipe connection to the furnace has not been provided. Sediment traps are designed to catch debris that may travel in the gas supply

pipe and is commonly required by the manufactures installation sheet. Review of the manufactures installation specifications for information related to the installation of this system is suggested. Improvements as needed are recommended.
