# Home Inspection Report

2240 Eastridge Ave, Menlo Park, CA 94025

# Inspection Details / Invoice

GRO090722PF

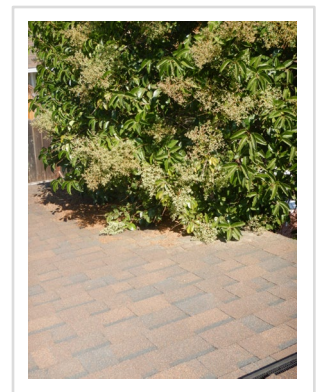
**MAINTENANCE** Overgrown vegetation or tree branches was contacting the roof. Tree contact with the roof can cause damage to the roofing material from abrasion over time and can be an access point for pests and rodents. We suggest trimming the tree/s as needed to provide adequate clearance.

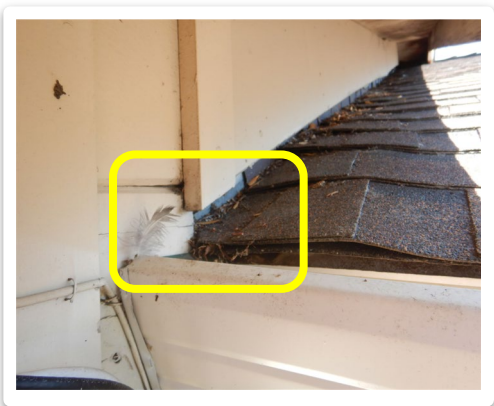
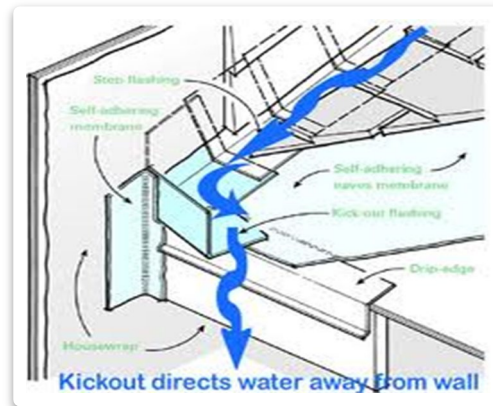
**REPAIR** The kick out step flashing at the west side of the garage appears to be incomplete and/or inadequately installed. This type of flashing is normally provided at the edge of a roof and wall connection to direct the roof run off away from the wall and into the gutter. The current configuration is not adequate and can allow moisture to penetrate into the exterior siding and the wall cavity leading to moisture damage. Repair to the kick-out flashing and filling / sealing the wall cladding is needed and should be undertaken to improve roof drainage at this location. Further evaluation and repair by a qualified roofing contractor is recommended.

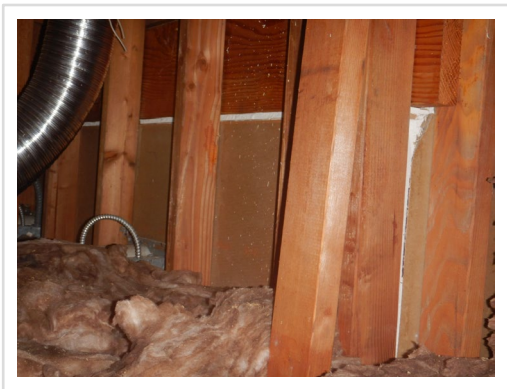
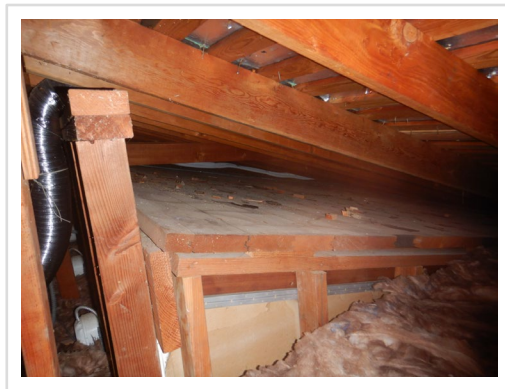
**UPGRADE** The open beam ceiling above the living room appears not to be insulated as is commonly found in homes of this type. Upgrades to insulate the roof in this area may be desirable for improved energy efficiency of the heating / cooling system.

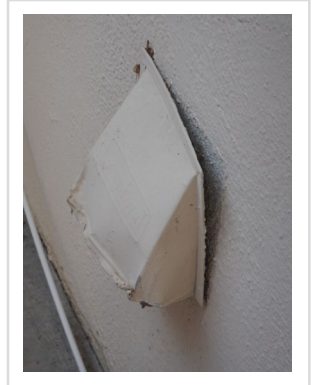
**SAFETY ISSUE** The dryer exhaust termination cap was damaged (crushed) blocking the function of the flapper door. A blocked dryer discharge system restricts the air flow and can be a fire hazard. **This condition presents a safety hazard and requires corrective action to reduce the potential for injury.** Repair to provide a functional self-closing termination cap is strongly recommended.

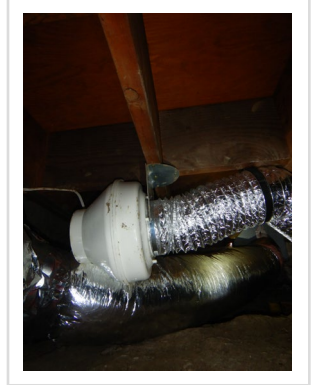
**FURTHER EVALUATION** This system is beyond the scope of the inspection and was not tested. Consulting with the seller or current occupant for additional information on this matter is suggested. Consulting with a qualified specialist in the appropriate trade for review and testing of this system is suggested.

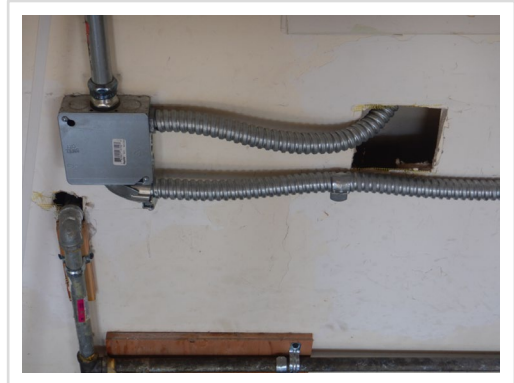
**REPAIR** Damage to the firewall between the house and the garage with a hole or opening was noted on the wall surface. This condition requires repair. Covering the damaged area with gypsum board or a fire rated sealant at all openings should be undertaken to maintain the fire resistive construction intended for this surface. Repairs to correct this condition are recommended.

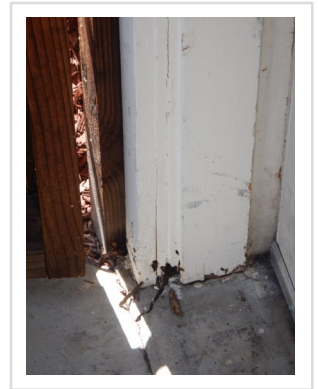
**UPGRADE** The exterior door in the garage is a hollow core or single panel type and not rated for exterior installation. Doors of this type are likely to deteriorate rapidly with exposure to the elements. Replacing the door slab with a solid core type rated for exterior installation is suggested.

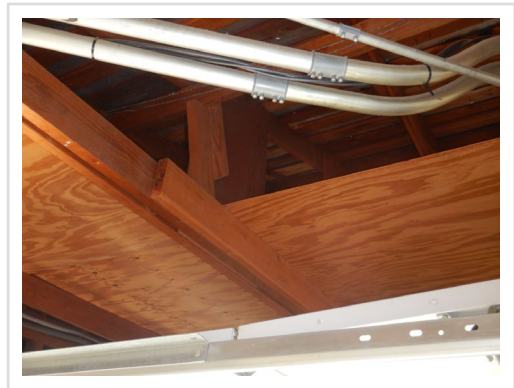
**SAFETY ISSUE** The side of the storage platform has not been provided with guard railing. This leaves this area susceptible to falling over the edge or from the platform. **This condition presents a safety concern and requires corrective action.** For enhanced safety, the installation of a guard railing is strongly recommended.

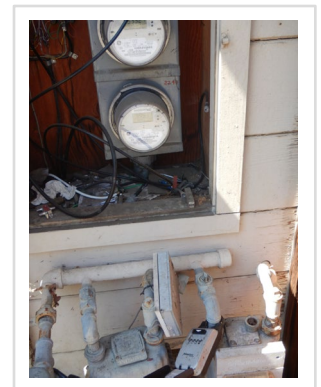
**REPAIR** The location of the gas meter in front of the main distribution panel is improper and limits front access to the panel. Commonly accepted construction standards require a clear area 30" wide, 36" deep and 6' 6" high in front of all electrical panels to provide adequate clearance for inspection and service. While not commonly practical, corrective action is recommended.

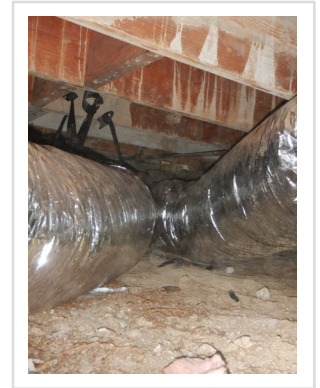
**REPAIR** One or more supply air ducts in the crawlspace was observed to be installed with inadequate clearance to grade or laying on grade. This is improper and can cause rapid deterioration and intrusion from moisture commonly found in the soils. The ductwork should be raised and strapped to maintain a 4” clearance from grade. Repair to correct this condition is recommended.

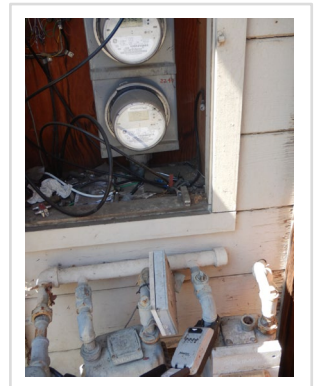
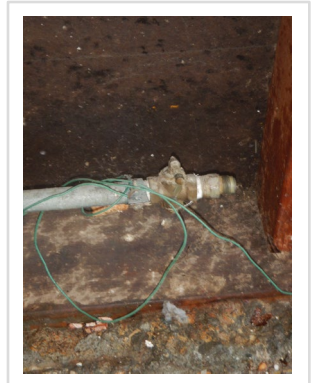
**UPGRADE** The gas shut-off valve at the dryer is older and considered at the end of its planned service life. Older gas shut-off valves can be stiff and difficult to close, jam or be prone to gas leakage. Replacement to upgrade to a new valve is a logical choice during routine maintenance of this system.

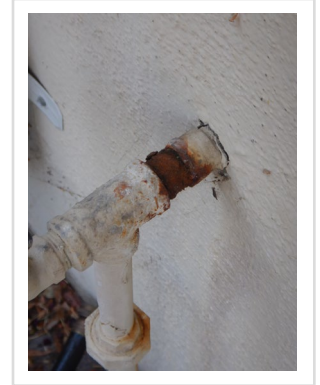
**REPAIR** Significant corrosion on the exterior of a section of iron supply piping or a fitting was observed at the north exterior wall. While no leakage was detected at the time of inspection, the level of damage indicates the need for immediate repair. Further evaluation and repair by a qualified plumbing contractor is recommended.

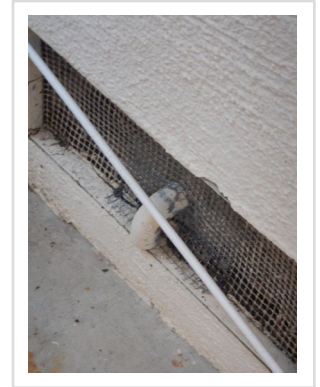
**SAFETY ISSUE** The discharge pipe serving the Temperature and Pressure Relief (TPR) Valve does not have adequate clearance at the end of the pipe at the east exterior wall. A minimum 6" (maximum 24") clearance at the end of the pipe is required to provide for a free flow of discharge when needed to prevent rupture of the storage tank. **This condition presents a safety hazard and requires corrective action to reduce the potential for injury.** Repair to cut the end of the pipe for increased clearance is strongly recommended.

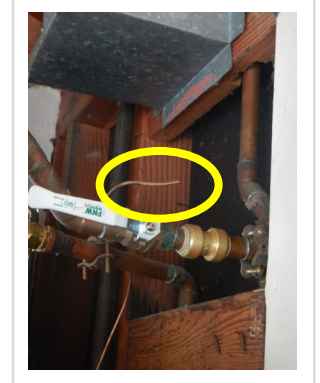
**REPAIR** A complete bonding system connecting the hot, cold and gas pipe was not visible on this water heater. Further evaluation and repair to correct this condition are recommended.

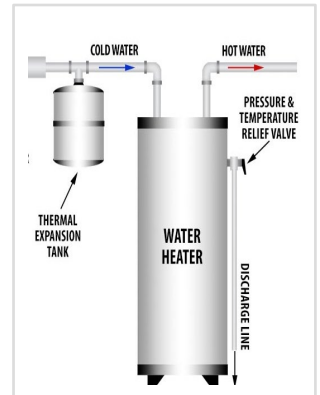
**REPAIR** Installation of a thermal expansion tank is recommended. Commonly accepted construction standards require installation of the thermal expansion tank when the water heater is replaced. The presence of a 'pressure regulator' at the main water supply shut-off restricts the flow of water off site and causes high water pressure from heating water. If additional information on construction requirements in this area is desired, consulting with the local building department having authority is suggested. We suggest consulting with a qualified plumbing contractor for further evaluation and installation as needed.

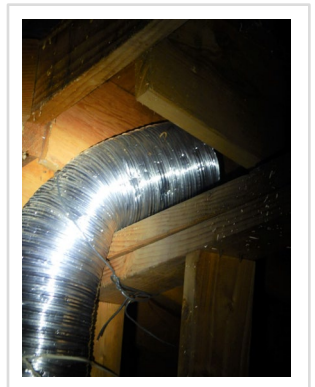
**REPAIR** The exhaust ductwork for this bathroom exhaust fan has not been installed to vent to the exterior. Without a duct system, the exhaust fan discharges into the attic allowing high moisture buildup. Review of the manufactures installation and operator's manual for information related to this system or component is suggested. Installing an exhaust ductwork to terminate to the exterior is recommended.

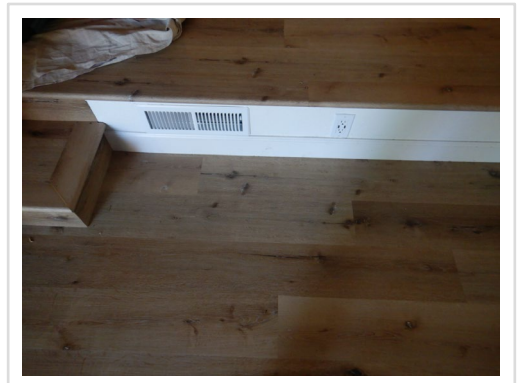
**SAFETY ISSUE** The step at the drop in the floor levels to the living room does not travel the entire width of the drop. A guard or barrier is commonly provided at this location. The variance of the drop-in height can be a tripping hazard and should be improved. **This condition presents a safety hazard and requires corrective action to reduce the potential for injury.** Repairs to correct this condition are strongly recommended.
