Saber Roofing, Inc.

Inspection Report

**2240 Eastridge Avenue
Menlo Park, CA 94025**

Inspected on Wed, Sep 7 2022 at 2:01 PM

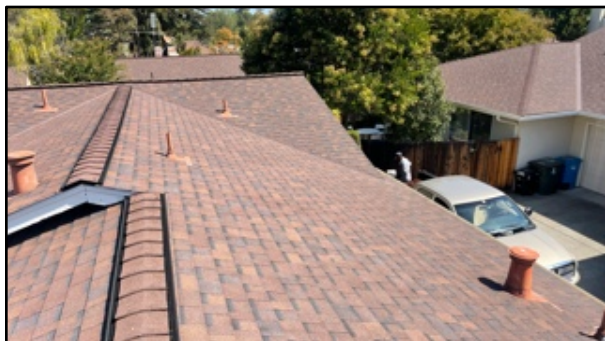
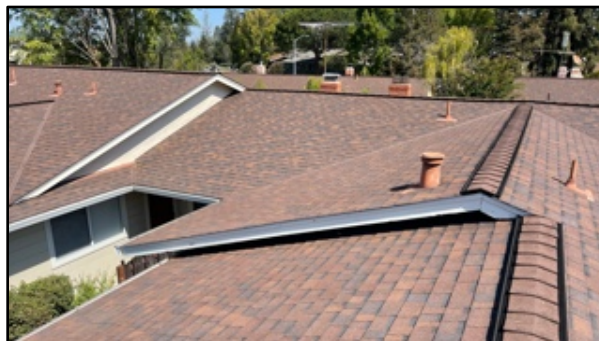
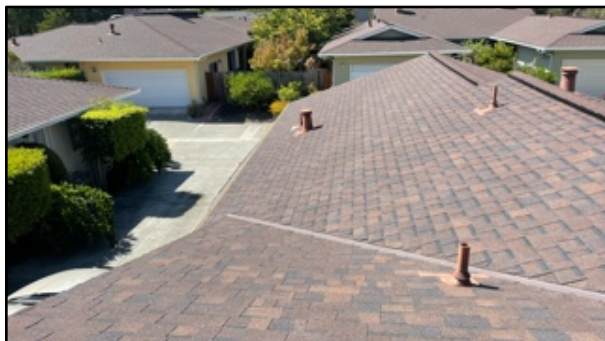
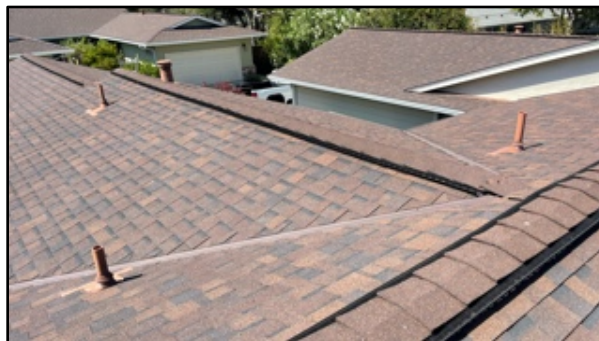
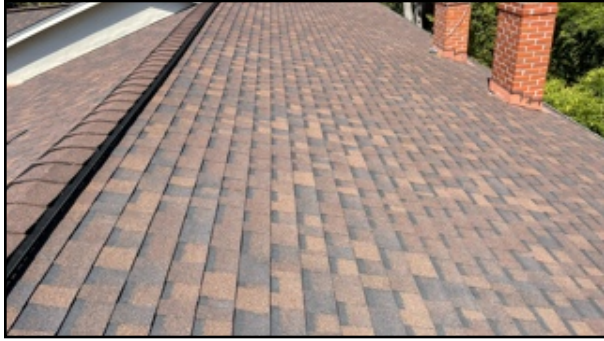
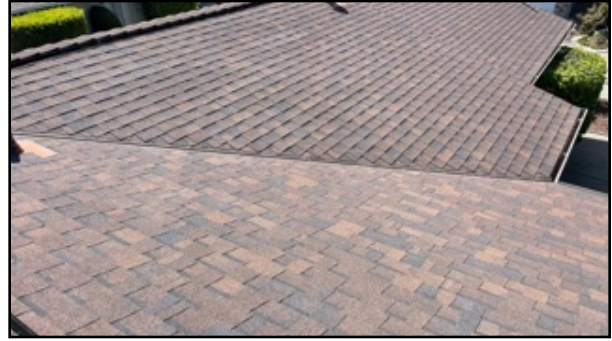
The above mentioned roof system is an asphalt shingle (1 layer) which has a rough life expectancy of 25~ years with proper maintenance and care. This roof system appears to be approximately 15 years old. With the continued maintenance this roof system should maintain a watertight condition for another 10~ years. This is in no way a stated or implied warranty but an opinion based on a visual inspection of the roof system. No repairs appear required at this time to maintain a watertight condition therefor this roof system has obtained a status of ROOF CLEARANCE (with exception of minor comments below).

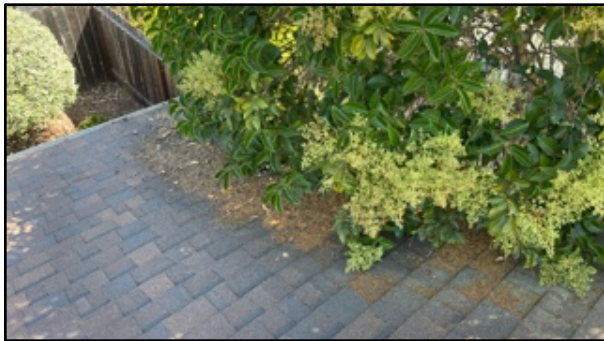
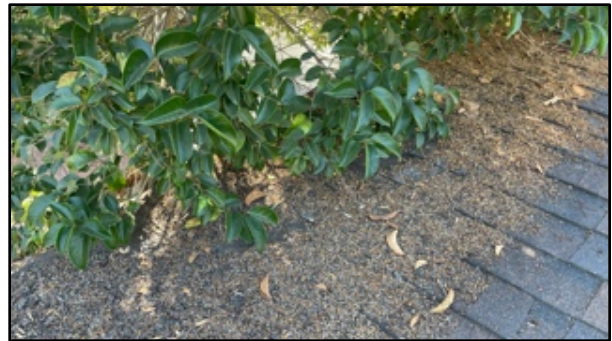
Overhanging branches were noted at the rear right side. Recommend cutting back from the roof system.

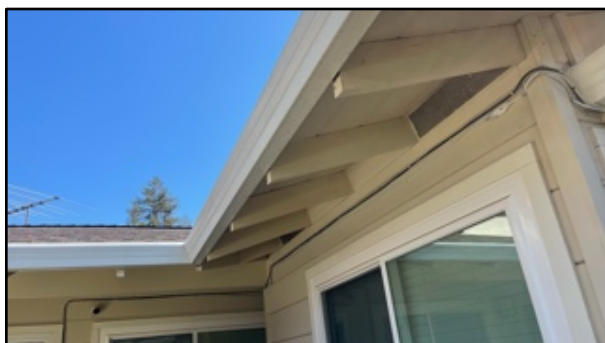
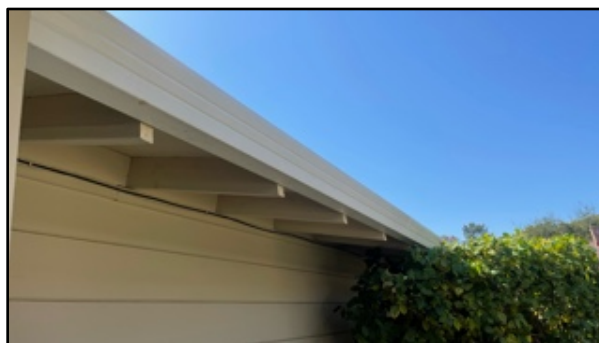
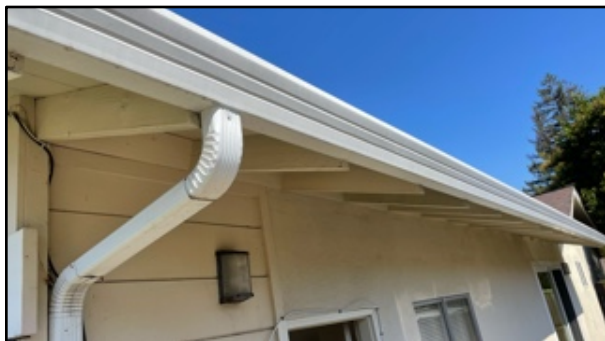
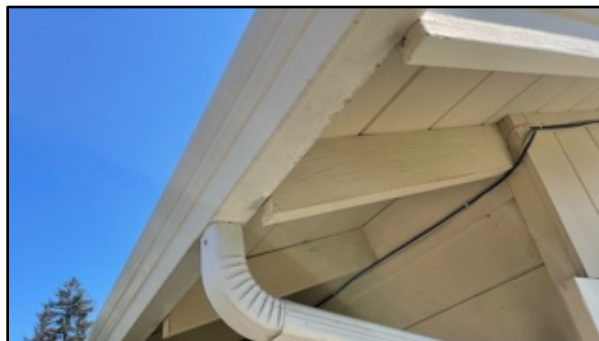
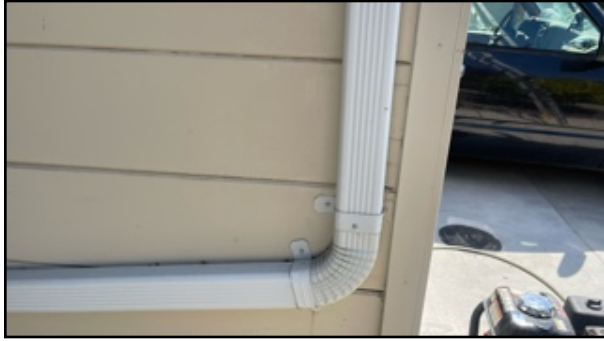
The existing gutters are 5" double lined aluminum fascia gutters with 2" x 3" aluminum downspouts. No visible repairs appeared required to the gutters other than the regular maintenance recommended below. With proper maintenance and care, this gutter system should last approximately 20+ years. This is in no way a stated or implied warranty but an opinion based on a visual inspection of the gutter system. Checking the slope is not part of this inspection.

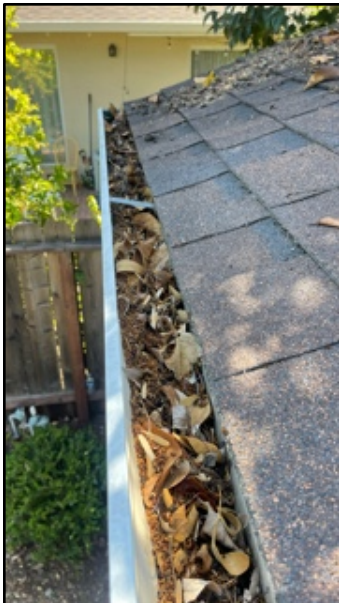
Figure 4-1

Minor debris was noted in the gutters, recommend regular maintenance to remove debris.
