Home Inspection Report

1111 Alma St, Palo Alto, CA 94301

LIN040122PF-NORTH

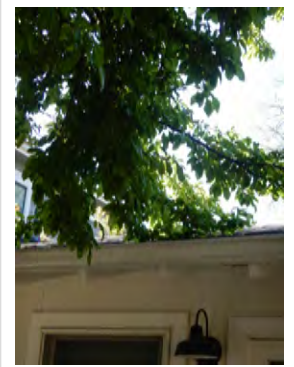
**MAINTENANCE** Overgrown vegetation or tree branches were contacting the roof at several locations. Tree contact with the roof can cause damage to the roofing material from abrasion over time and can be an access point for pests and rodents. We suggest trimming the tree/s as needed to provide adequate clearance.

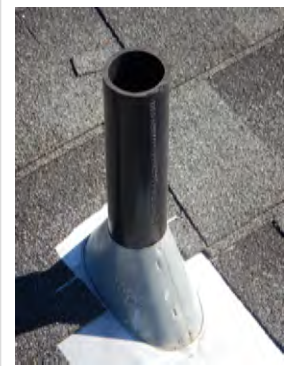
**UPGRADE** The black ABS plastic vent pipes on the roof at several locations have not been protected from the damaging rays of the sun. Typically, a single coat of latex paint is sufficient to provide this protection. Improvement as needed to coat the exposed vent pipe/s terminations is recommended.

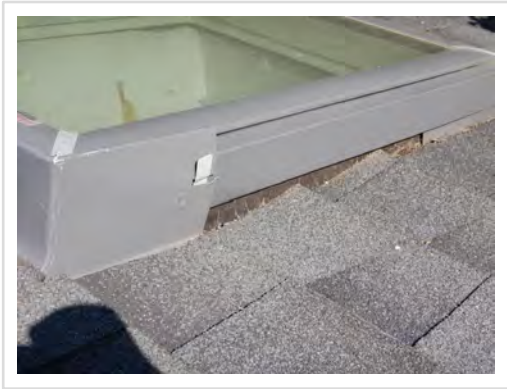
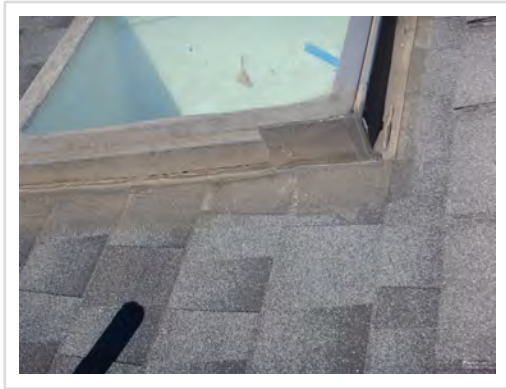
**REPAIR** The installation of the skylight flashing at the roof connection has not been completed with one or more missing pieces. The flashing is intended to seal the skylight to the roof. The lack of a complete flashing system at this location does not meet the manufacture's installation requirements and leaves it prone to leakage and moisture damage. Review of the manufacture's installation and/or operator's manual for information related to this system or component is suggested. Further evaluation and repair by a qualified roofing contractor is recommended.

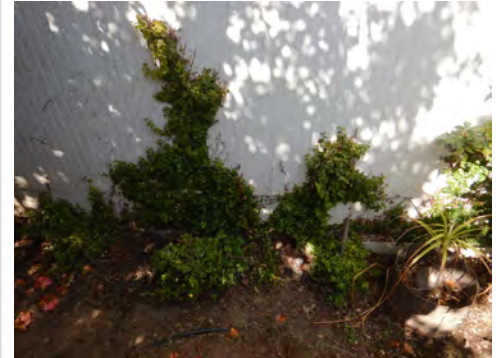
- 7   **FURTHER EVALUATION** The vegetation against the exterior wall of the home at several locations prevents a complete inspection of the exterior cladding. This is a limited area of inspection. No conclusions are made or offered in inaccessible areas. Maintaining a clearance to the exterior cladding in this area is recommended to provide adequate air circulation. High moisture levels and abrasion can lead to damage of the exterior wall surfaces. Review of this area when trimmed to assure a well-sealed surface is provided is suggested.

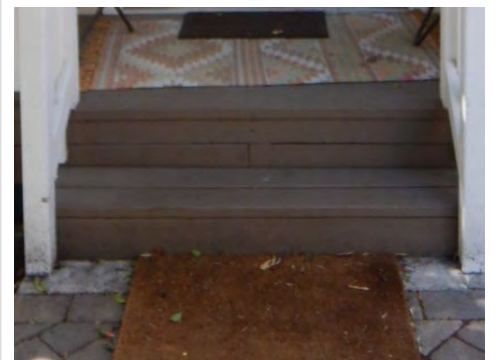
**SAFETY ISSUE** The steps are uneven. Steps that vary more than 3/8" in height are considered a tripping hazard and should be improved. ***This condition presents a safety hazard and requires corrective action to reduce the potential for injury.*** While repairs are recommended this condition is often lived with. If not repaired, caution and extra care are needed to negotiate these steps.

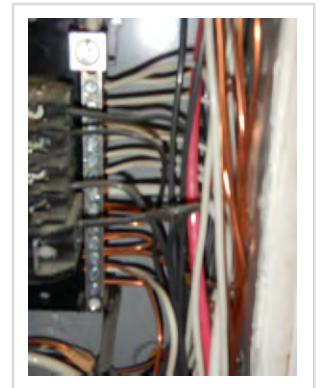
**CLIENT ADVISORY** For the client's information it was noted that one or more circuit breakers in this electrical panel are not currently connected to any wiring. The unused circuit breakers appear to be 'spare/s' and provided for future expansion. No action is needed on this item at this time.

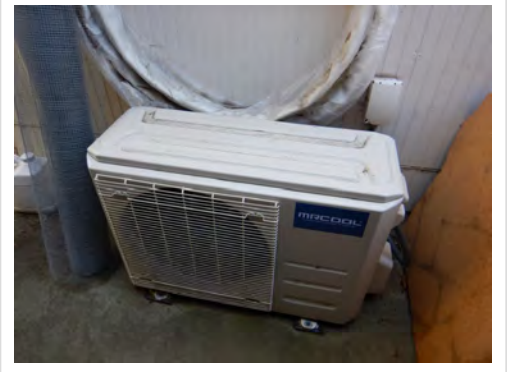
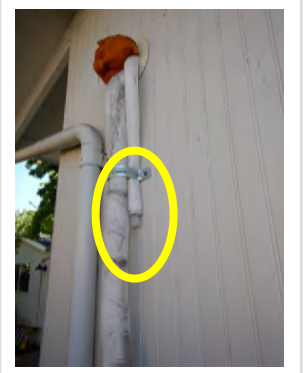
The coolant lines where visible, appear to be well connected and in good condition overall. Adequate insulation has been provided on the return line.

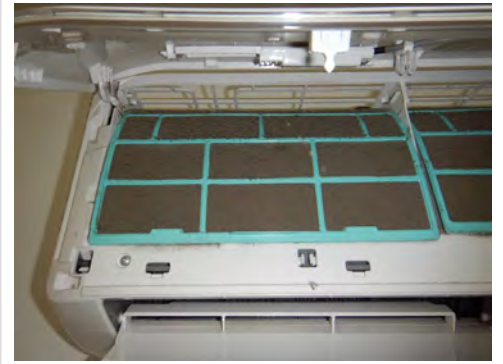
**MAINTENANCE** The air filter in the register is dirty. Cleaning or replacement of the air filter element should be undertaken. Regular replacement of the furnace air filter is required to maintain the proper efficiency and operation of the furnace. Improvements are recommended.

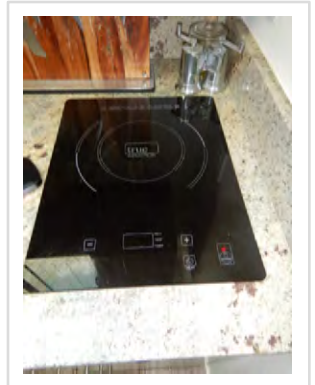
**CLIENT ADVISORY** Inspection of this type of cooking system is limited to a general visual review. This is a limited area of inspection. Use specific cookware is required for this technology. The inspector does not engage the unit or verify its function. We suggest testing to verify proper function with the appropriate cookware. Consulting with the seller or current occupant for additional information on the history and performance of this system is suggested.

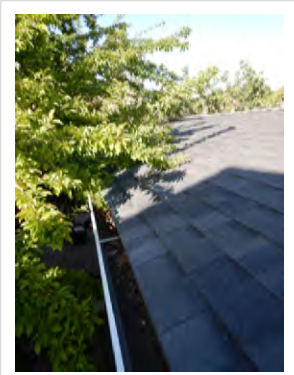
**MAINTENANCE** Overgrown vegetation or tree branches was contacting the roof. Tree contact with the roof can cause damage to the roofing material from abrasion over time and can be an access point for pests and rodents. We suggest trimming the tree/s as needed to provide adequate clearance.

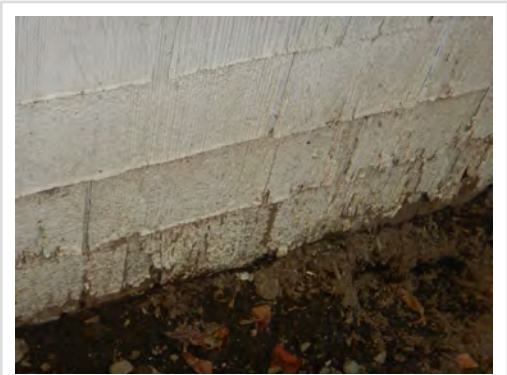
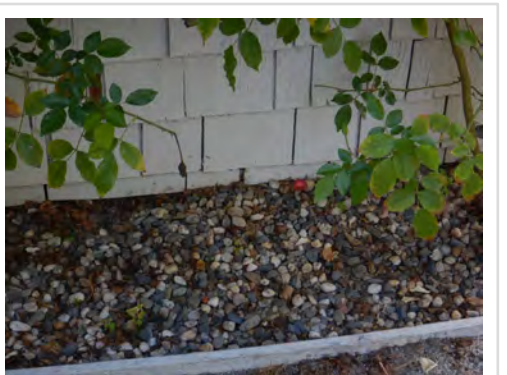
**MAINTENANCE** The wood exterior siding has direct earth contact. Generally, a 6" clearance should be maintained between the dirt and any wood on the structure to prevent moisture damage and increased activity by wood boring insects. Review of a current pest control report may provide additional information. Improvements as needed to correct this condition are suggested.

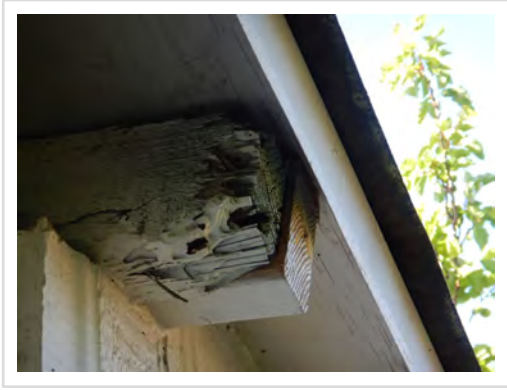
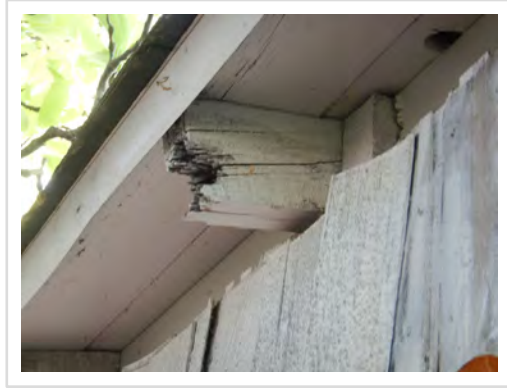
**REPAIR** Evidence of localized moisture damage was observed at one of the wood rafter tails along the south side of the home. Improvement to repair or replace the affected area is needed to prevent further damage. Review of a current pest control report is suggested and may provide additional information on this condition. Repairs to correct this condition are recommended.

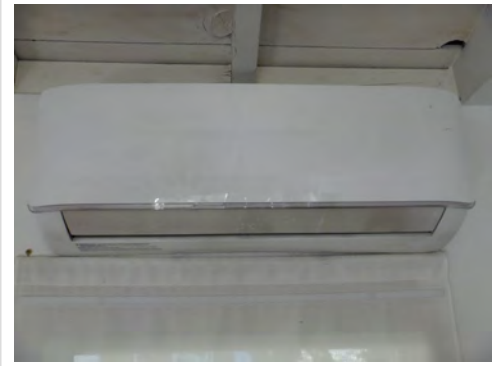
The mini-split cooling system responded to controls and appeared to function adequately during testing. A 12 degree (Fahrenheit) drop in air temperature was recorded at the supply registers when compared to the intake temperature measured at the return register.

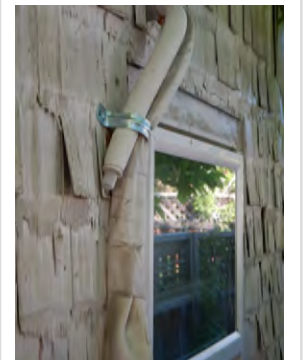
**REPAIR** The condensate drainpipe does not extend fully to grade and terminates high on the wall. The discharge of condensate can flow onto the exterior cladding and lead to moisture damage of the siding and/or wood framing at this location. Repair to install a pipe extension to grade is recommended. We suggest consulting with a qualified heating and cooling HVAC contractor for further evaluation and repair as needed.

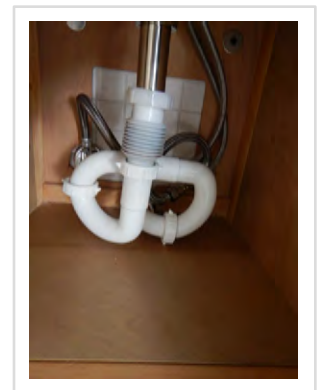
**UPGRADE** The use of a temporary 'ribbed plastic' drainpipe fitting under the sink was noted. A pipe fitting of this type is not intended for permanent use and is likely to deteriorate or clog over time. Improvement to replace this fitting with one rated for this installation is recommended.

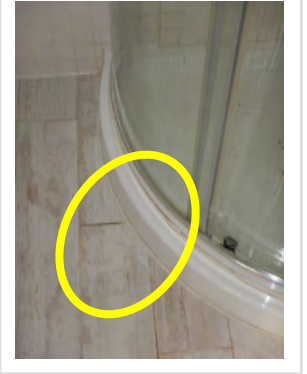
**MAINTENANCE** The shower was observed to drain slowly, suggesting that an obstruction may exist. A slow draining condition is likely to worsen over time. Maintenance to clear the drainpipe is advisable.
