REAL ESTATE TRANSFER DISCLOSURE STATEMENT (CALIFORNIA CIVIL CODE \$1102, ET SEQ.)

(C.A.R. Form TD Signevised 4/14) DATE THIS DISCLOSURE STATEMENT CONCERNS THE REAL PROPERTY SITUATED IN THE CITY OF Menlo Park **COUNTY OF** San Ma Sign SDATE OF CALIFORNIA. **DESCRIBED AS** 2240 Eastridge Avenue, Menlo Park, CA 94025 THIS STATEMENT IS A DISCLOSURE OF THE CONDITION OF THE ABOVE DESCRIBED PROPERTY IN

NOTE: This is a limited inspection report. This inspection is limited to 2240 Eastridge Avenue, Menlo Park only. The inspection was performed at the request of Ric Parker. A further inspection of the entire structure is recommended, but was not performed at this time.

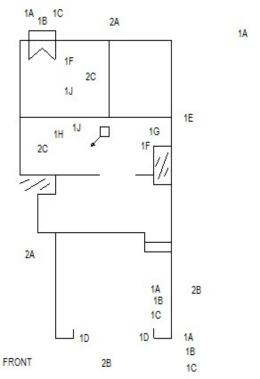
DIAGRAM NOT TO SCALE

ITEM 1A FINDING: Evidence of drywood termite activity was noted at the subarea framing, exterior and garage framing. These infestations may extend into inaccessible areas.

ITEM 1C FINDING: Drywood termite pellets were noted at the subarea framing, exterior and garage framing.

ITEM 1D FINDING: Fungus damage and drywood termite damage were noted at the large garage door jambs.

FINDING: Fungus damage was noted at the 2"x6" barge rafter tail.

ITEM 1F FINDING: Fungus damage was noted to the subfloor below the master bathroom tile floor. Leaks were found at the toilet. Concealed damage may be revealed.

ITEM 1H FINDING: Cracks and loose tiles were found at the hall bathroom tubback. This has allowed moisture to enter causing fungus damage to the sheetrock backing. Concealed damage may be revealed.

ITEM 1I FINDING: There is inadequate ventilation below the living room area. This has resulted in fungus infection at the subarea framing, see item #1J.

FINDING: As indicated in item #11 there is inadequate ventilation below the living room. Surface fungus infections were noted at the subarea framing and plywood subfloor below the living room area.

ITEM 2A FINDING: The stucco extends into the soil at the exterior of the structure. Inaccessible areas exist due to this condition. This may provide an entry point for subterranean termites.

ITEM 2B FINDING: Signs of weathering were noted at the siding.

ITEM 2C FINDING: There are heat ducts in the subarea that are down and rusted.

RECOMMENDATION: Fumigate the entire structure with Vikane gas for complete, guaranteed eradication of all drywood termite infestations.

RECOMMENDATION: Remove, vacuum and/or mask all accessible drywood termite pellets as noted.

RECOMMENDATION: Remove the damaged door jambs and replace with new materials, sealing all voids. The repaired areas will be primer painted only. If any further damage is found a supplemental report will be issued with our additional findings and cost.

RECOMMENDATION: Remove the damaged section of the barge rafter and replace with new materials. These repairs will also include replacement of the shingle moulding, if needed. The repaired areas will be primer painted only. If any further damage is found a supplemental report will be issued with our additional findings and cost.

RECOMMENDATION: Remove the toilet. Remove the complete marble tile floor. Remove the damaged subfloor. If no further damage is found new subfloor will be replaced/reinforced as needed. Install new marble tile throughout the bathroom floor. The new tile will be set in a mortar base. If any further damage is found a Supplemental Report will be issued with our additional findings and costs.

RECOMMENDATION: Remove the ceramic tile and sheetrock at the tubback walls. If no framing damage is found, new sheetrock will be installed, taping and sealing all voids. New ceramic tile will be installed at the tubback walls. The new tile will be set in a mortar base. If any further damage is found a supplemental report will be issued with our additional findings and cost.

RECOMMENDATION: Install new mechanical power fans/vents to help improve the cross ventilation in the substructure. These vents will be located at the most accessible areas in order to draw air into the substructure. The vents will be set, installed and hardwired at each location. The necessary duct work will be installed at each of the fans/vents. If necessary, we will primer paint the exterior stucco and/or siding.

RECOMMENDATION: Scrape and/or wire brush off all surface fungus infections and treat with a registered fungicide.

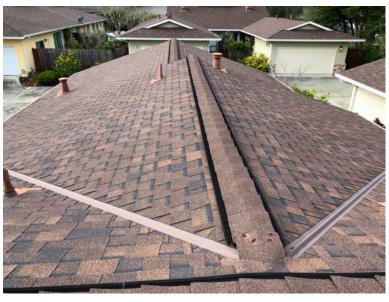
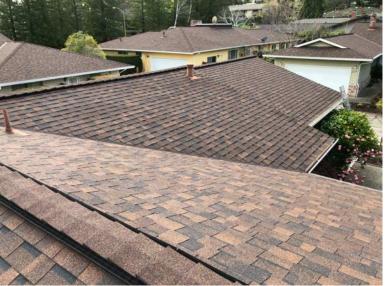
Overview Overview

The composition shingle roof on this dwelling is in good condition materially. The roof appears to be watertight, with no obvious need for repairs. We suggest that you review the note section on page 2 of this roof report.

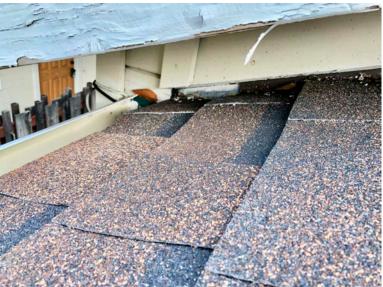
Overview Note A

A.	The bottom most metal roof-to-wall step flashing does not turn out from the exterior wood siding, where the left
	eave, (over the garage), intersects a short wall between the garage and house. A soldered kicker step flashing was
	not used. This condition may allow water, which runs off the bottom most step flashing, to run behind the siding
