Home Inspection Report

1111 Alma St, Palo Alto, CA 94301

LIN033122PF

Thursday, March 31st 2022

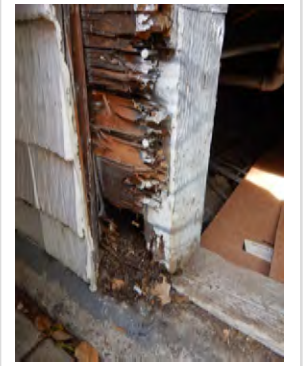
**REPAIR** Staining with moisture damage to the base of the exterior cripple wall wood framing was noted in the crawlspace at several locations. The level of damage indicates ongoing moisture intrusion at this location and the need for repair. Further evaluation of this condition is recommended. Repair to replace the affected material is needed. Review of a current pest control report is suggested and may provide additional information on this condition.
