Saber Roofing, Inc.

Inspection Report

**1111 Alma Street
Palo Alto, CA 94301**

Inspected on Tue, Apr 5 2022 at 10:00 AM

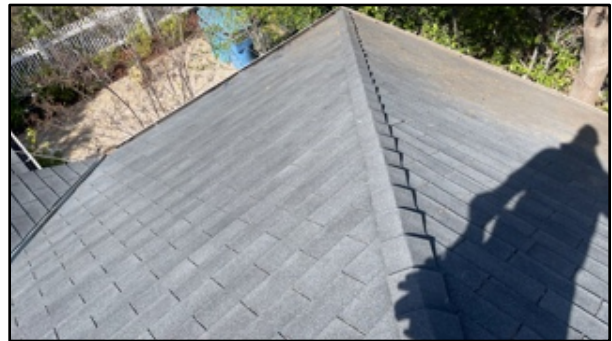
Figure 1-2

HOUSE: The above mentioned roof system is an asphalt shingle (1 layer) which has a rough life expectancy of 20-25 years with proper maintenance and care. This roof system appears to be approximately 15 years old. With the below mentioned deficiencies being rectified and proper maintenance and care, this roof should provide for a watertight condition for the next 5+ years. This is in no way a stated or implied warranty, but an opinion based on a visual inspection of the roof system.

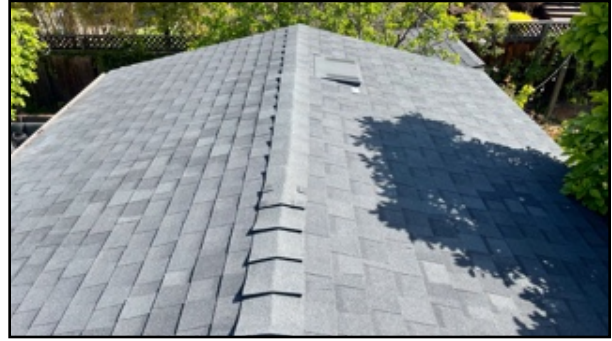
Figure 2-2

RIGHT SIDE ADU: The above mentioned roof system is an asphalt shingle (1 layer) which has a rough life expectancy of 25+ years with proper maintenance and care. This roof system appears to be approximately 2-6 years old. With the below mentioned deficiencies being rectified and proper maintenance, this roof system should provide for a watertight condition for the next 10+ years.

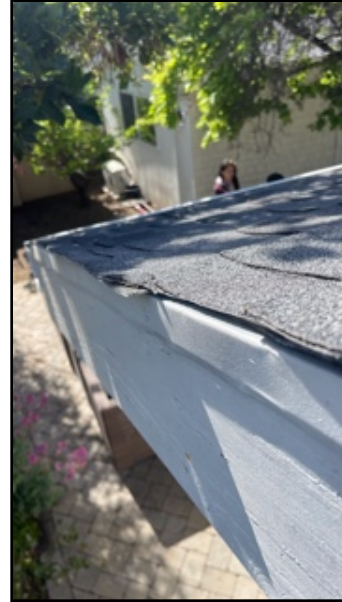
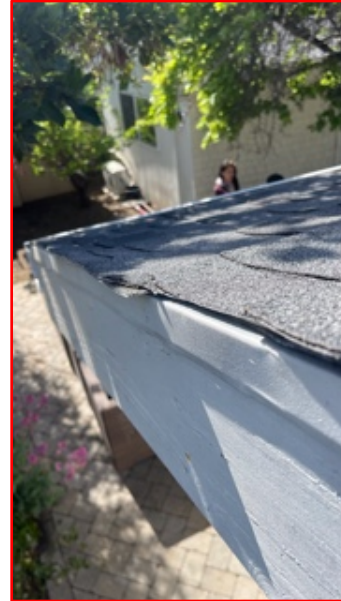
Figure 4-2

The shingles do not overhang the recommended 1/2-1" at miscellaneous locations of the rear left side ADU. Repairs recommended.

1) The shingles do not overhang the recommended 1/2-1" at miscellaneous locations of the rear left side ADU. Repairs recommended.

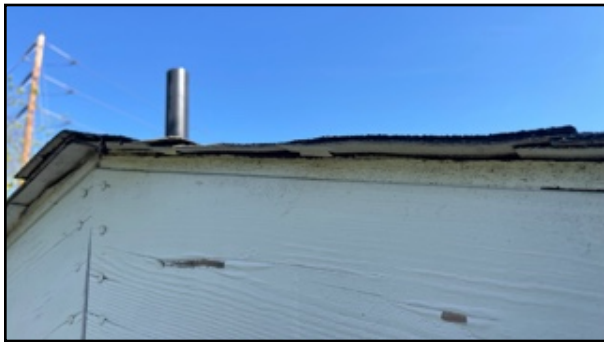
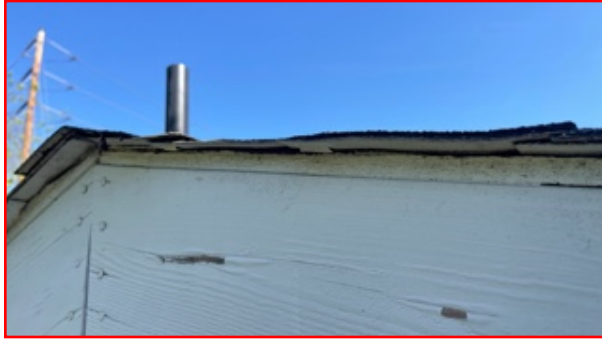
Figure 5-3

No starter strip/shingle was installed at the eaves nor appropriate edge metal/nosing to protect the edge of the plywood at the rear left side ADU. Repairs recommended.

2) No starter strip/shingle was installed at the eaves nor appropriate edge metal/nosing to protect the edge of the plywood at the rear left side ADU. Repairs recommended.

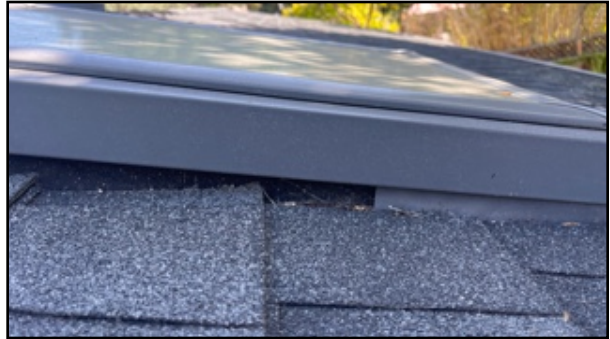
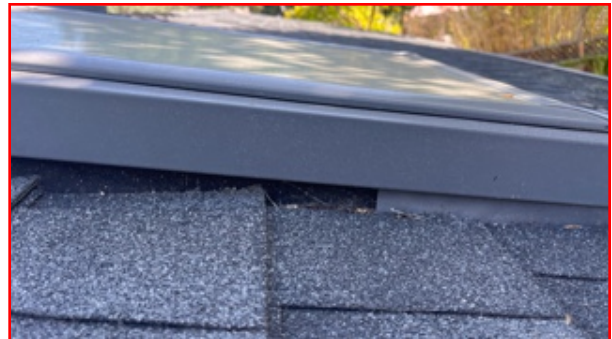
Figure 6-2

Missing and uplifted skylight flashings were noted at the bathroom skylight of the rear left side ADU. Repairs recommended.

3) Missing and uplifted skylight flashings were noted at the bathroom skylight of the rear left side ADU. Repairs recommended.

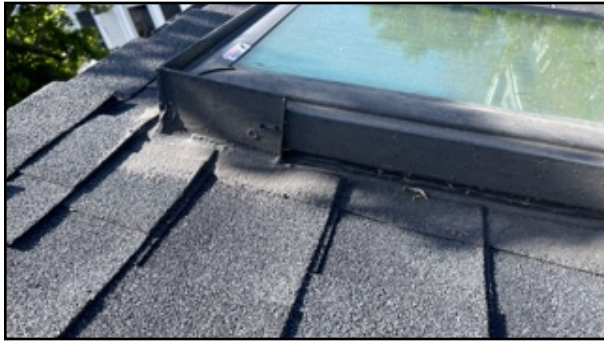
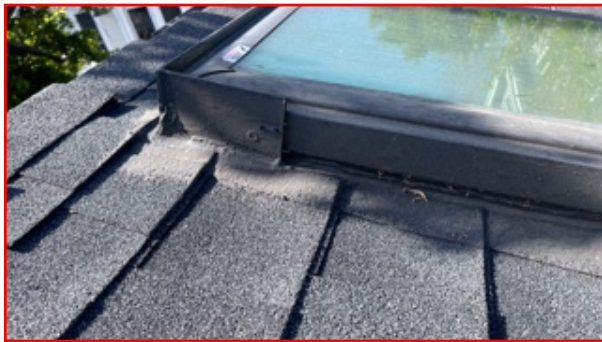
Figure 8-3

Sealant has been applied to the entire skylight and flashing kit at the living room skylight on the rear left ADU. Repairs recommended.

5) Sealant has been applied to the entire skylight and flashing kit at the living room skylight on the rear left ADU. Repairs recommended.

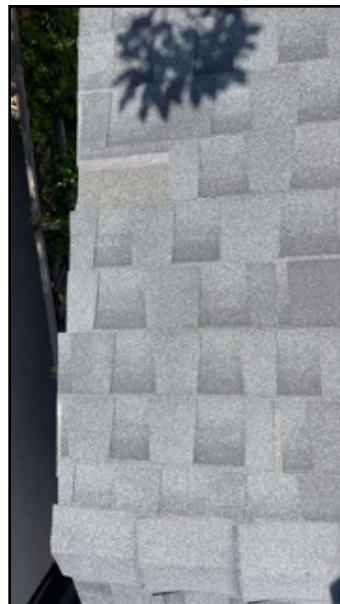
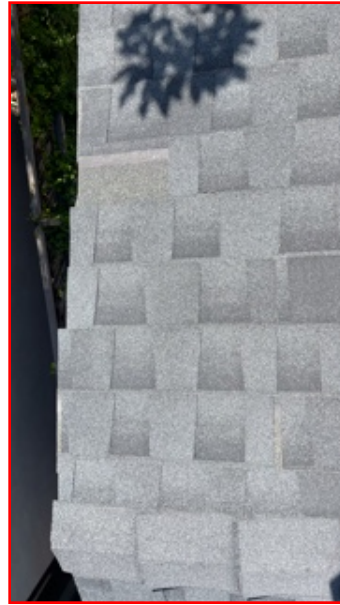
Figure 9-2

The existing shingles on the rear left side ADU are overexposed and not installed per manufacturer's recommendations. No repairs are possible to correct this deficiency.

6) The existing shingles on the rear left side ADU are overexposed and not installed per manufacturer's recommendations. No repairs are possible to correct this deficiency.

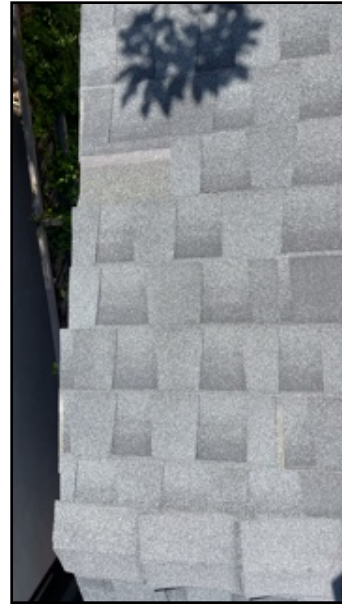
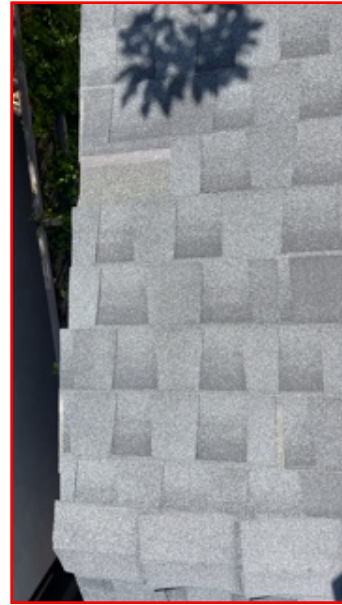
Figure 11-2

Missing shingles and improperly installed shingles were noted at the rear left side ADU. Repairs recommended.

8) Missing shingles and improperly installed shingles were noted at the rear left side ADU. Repairs recommended.

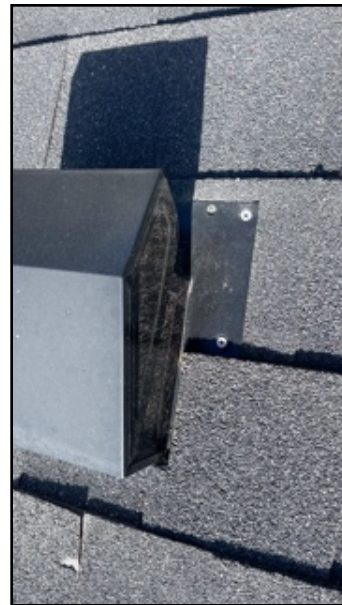
Figure 12-2

Exposed fasteners were noted at the right side ADU and main house. Repairs recommended.

9) Exposed fasteners were noted at the right side ADU and main house. Repairs recommended.

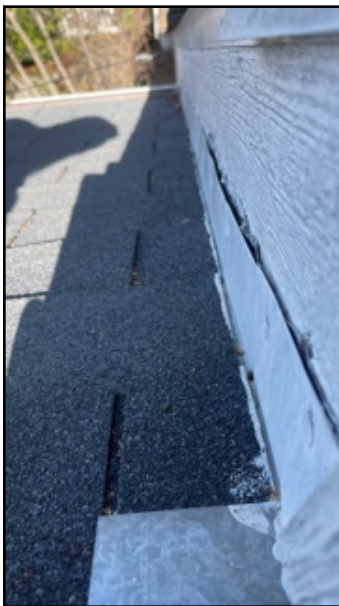
Figure 14-3

Inadequately sealant and/or improperly counter-flashed step shingles were noted at multiple roof to wall junctions. Repairs recommended to ensure proper waterproofing.

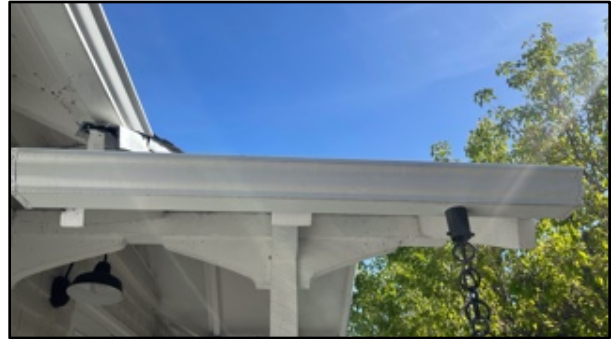
Figure 18-2

The existing gutters appear to be 5" aluminum ogee style with 2" round downspouts. In general the gutters were in serviceable condition unless otherwise noted.

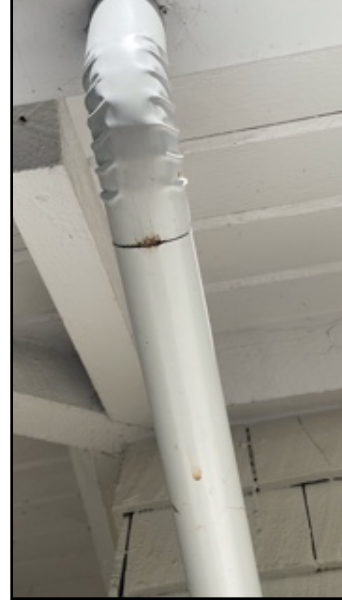
Figure 19-2

**Comment 19:**
Multiple stains/leaks were noted at the drop outlet/downspout connections.
Sealant repairs recommended.

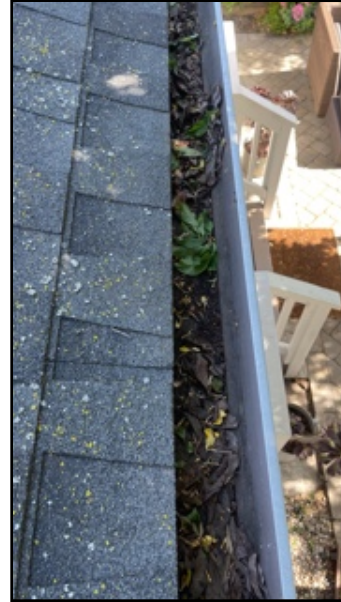
Figure 20-2

Considerable debris build up was noted inside the gutters. Regular maintenance recommended to ensure proper water drainage.

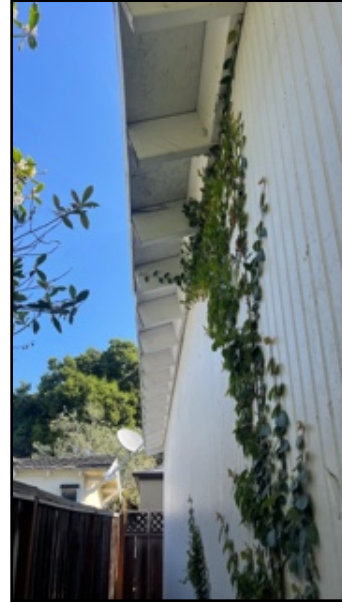
Figure 21-2

Portions of the ADU's do not have gutter systems installed. Recommend continued monitoring to see if gutter installation is required.

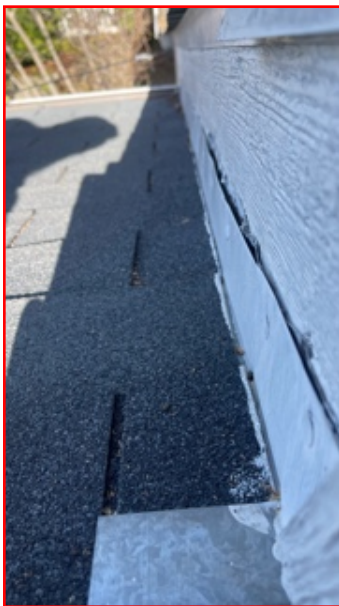
Figure 14-3

11) Inadequately sealant and/or improperly counter-flashed step shingles were noted at multiple roof to wall junctions. Repairs recommended to ensure proper waterproofing.

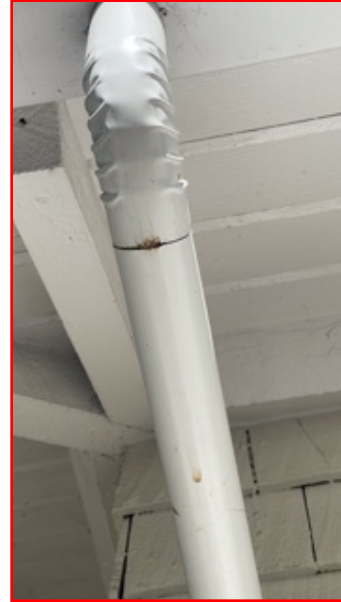
Figure 19-2

15) Multiple stains/leaks were noted at the drop outlet/downspout connections. Sealant repairs recommended.

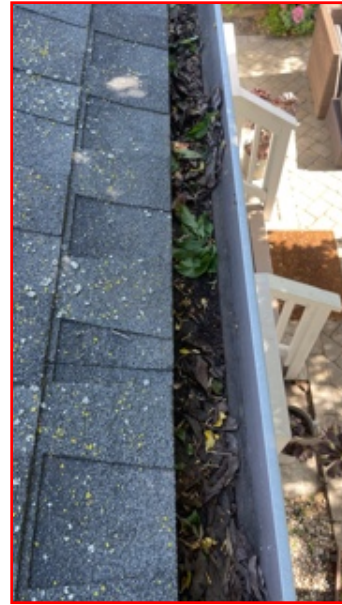
Figure 20-2

16) Considerable debris build up was noted inside the gutters. Regular maintenance recommended to ensure proper water drainage.

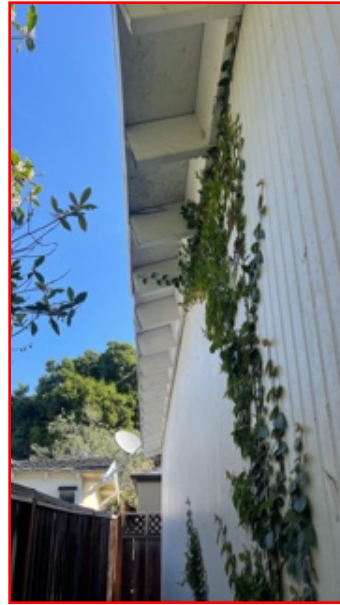
Figure 21-2

17) Portions of the ADU's do not have gutter systems installed. Recommend continued monitoring to see if gutter installation is required.
