FOUNDATION & DRAINAGE INSPECTION REPORT

1111 Alma Street, Palo Alto

Inspection Date: 4/4/2022

Address: 1111 Alma Street, Palo Alto

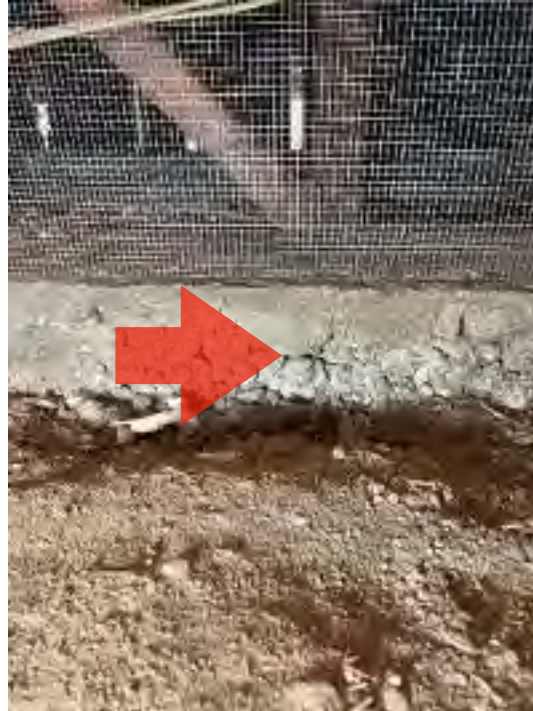
Item Image 1

- **Observation Details:** There are various forms of spalling but this one is the result of the chemical breakdown of the cement within the concrete mix (rock, sand, cement). Typical causes of spalling concrete include but are not limited to the following: excessive moisture and/or poor site drainage conditions, poor quality cement used in the concrete mix, the ratio of cement with relationship to the amount of sand and rock in the concrete mix is too low & the sand used in the concrete mix has excess salt-mineral residue. We can see one area on the left side as shown in Image 6 where it appears a portion of the foundation was capped (the background and purpose of this is unknown).
