# Home Inspection Report

2240 Eastridge Ave, Menlo Park, CA 94025

# Inspection Details / Invoice

GRO090722PF

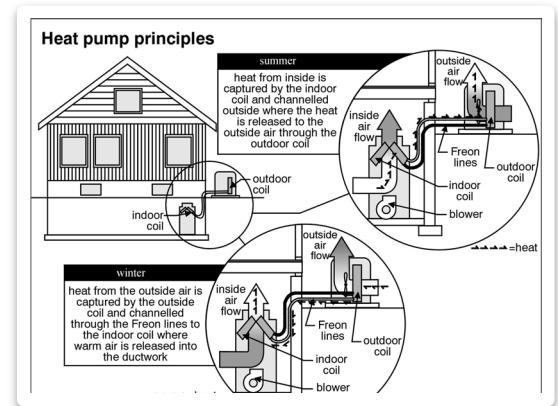
### Electric Heat Pump - Heating System

The heating and cooling for this home is provided by an electric heat pump system. The heating mode of this system utilizes the outdoor compressor unit to convert a coolant gas to liquid coolant, which is forced into the indoor coil. Air blowing across the coil condenses the coolant from a gas into a liquid. In the conversion from gas to liquid, heat is released into the supply of air and into the home. Some heat pump systems also include an electric heating element for back up heat during extreme cold conditions. The heating mode of the heat pump system was engaged and operated during the inspection process. The unit responded to the operator controls and was operational. Regular maintenance and upkeep will of course be needed to ensure long-term operation of this system.

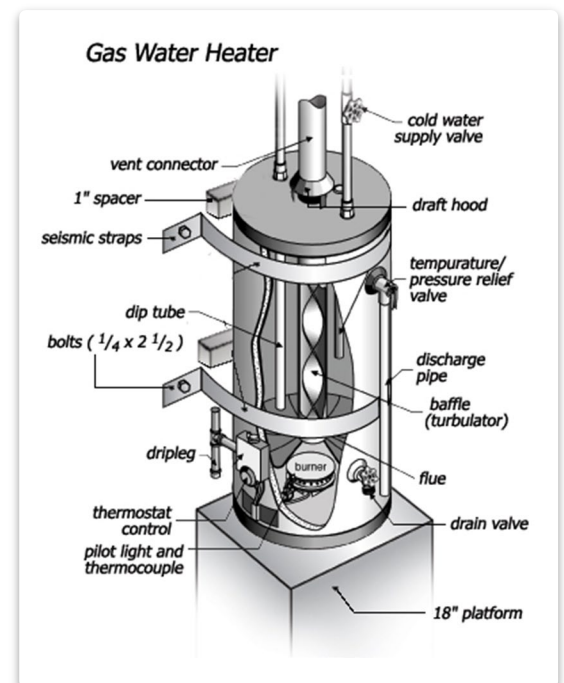
### Water Heater Platform

The water heater has been provided with a raised platform to position the flame a minimum of 18" from the garage floor. This is a beneficial addition and is intended to reduce the likelihood of ignition of flammable liquids should they be spilled.

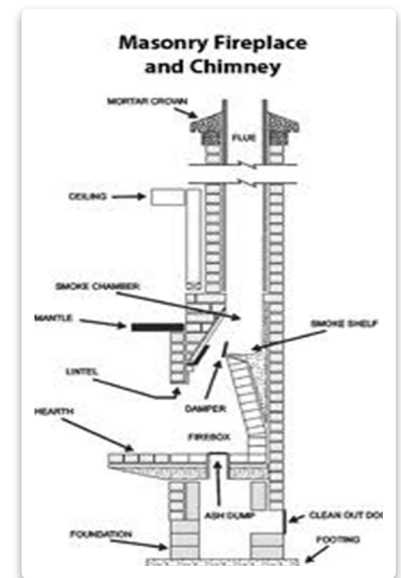
#### Fireplace Hearth Extension

A non-combustible hearth extension has been provided directly in front of the fireplace. The non-combustible materials used for the hearth serves a valuable purpose in reducing the chance of accidental fire from hot embers falling out of the fireplace. The hearth material appears to be in sound condition and without visible damage.
