# WOOD DESTROYING PESTS AND ORGANISMS INSPECTION REPORT

BUILDING NO. <b>2240</b>	STREET, CITY, STATE, ZIP <b>Eastridge Avenue, Menlo Park CA 94025</b>	Date of Inspection <b>9/6/2022</b>	No. of Pages <b>8</b>
-----------------------------	--	---------------------------------------	--------------------------

General Description: One story, wood framed, townhouse with wood, stucco and stone veneer exterior.	Inspection Tag Posted: Garage
	Other Tags Posted: None noted in the last two years

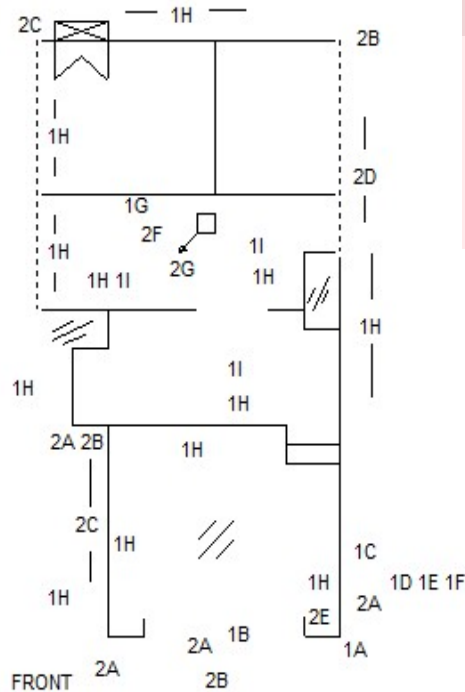
DIAGRAM NOT TO SCALE

An inspection has been made to the structure(s) shown on the diagram in accordance with the Structural Pest Control Act. Detached porches, detached steps, detached decks and any other structures not on the diagram were not inspected.

NOTE: This is a limited inspection report. This inspection is limited to the this address only, at the areas indicated on the diagram only. The inspection was performed at the request of Kevin Lu. A further inspection of the entire structure is recommended, but was not performed at this time.

ITEM 1A FINDING: Drywood termite damage was noted to the 3"x3" corner trim.

ITEM 1B FINDING: Minor fungus damage was noted to the 2"x12" belly band.

ITEM 1C FINDING: Subterranean termite damage was noted to the small garage door jamb and 1"x3" trim.
